SUMMARY REPORT

Agreement RFQ No. 456-11637
City of Fort Lauderdale Project No. P12212
Task Order No. 1 Seawall Master Plan

BCC Engineering, Inc.
Certificate of Authorization No. 7184

February 5, 2018

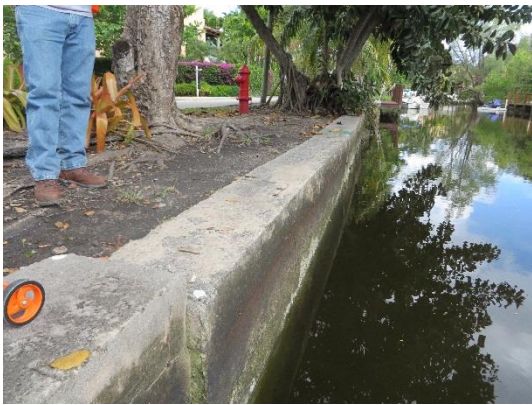
- 1) External (global) stability. Signs of overall distress or loss of stability threatening property adjacent to or behind the seawall.

Figure 2.7.1 Lateral Movement/Rotation

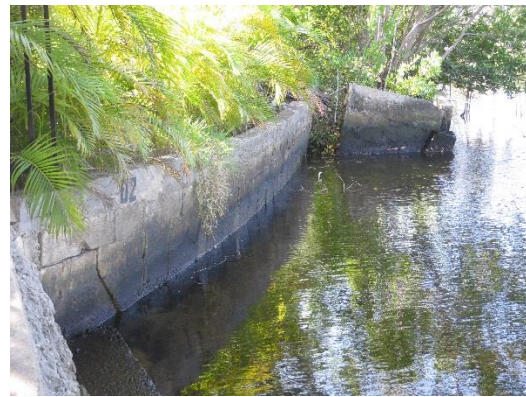
Figure 2.7.2 Lateral Movement/Separation

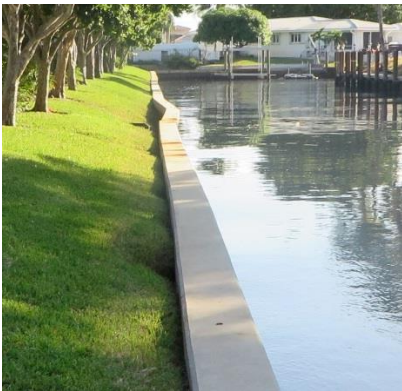
- 2) Internal (structural) stability. Deterioration or failure of a seawall component.

Figure 2.7.3 Tie Back Failure

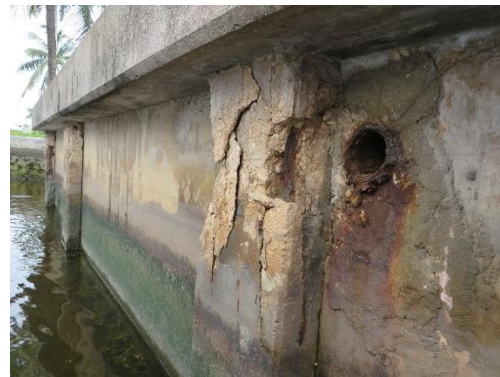
Figure 2.7.4 T-Pile Spall and Panel Cracking

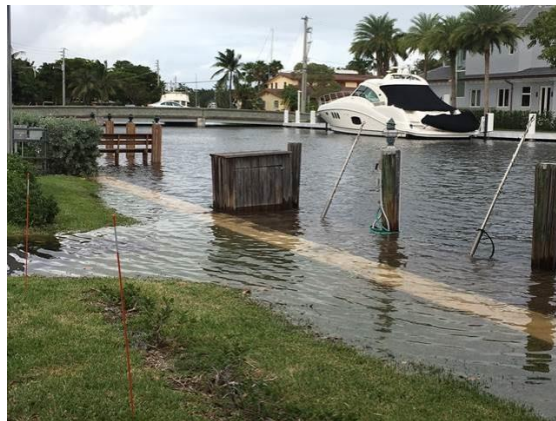
Figure 2.7.5 Cordova Road (Seawall No. 29) During King Tide Conditions

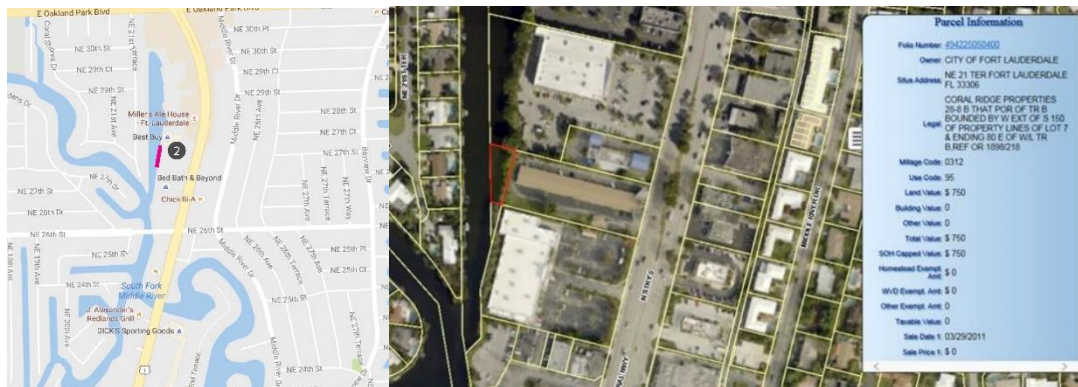
- 1) Access. Seawalls accessible by land requiring access through private property impacts construction. Seawalls accessible by water restricted by low-level bridges creates issues with equipment access. Seawall 2 (pictured below) involves both of these challenges due to a fixed bridge on NE 26th Street, restricted waterway bordering a residential area, and its location directly behind a Budget Inn.

Figure 2.8.1 Accessibility Issues – Featuring Seawall No. 2

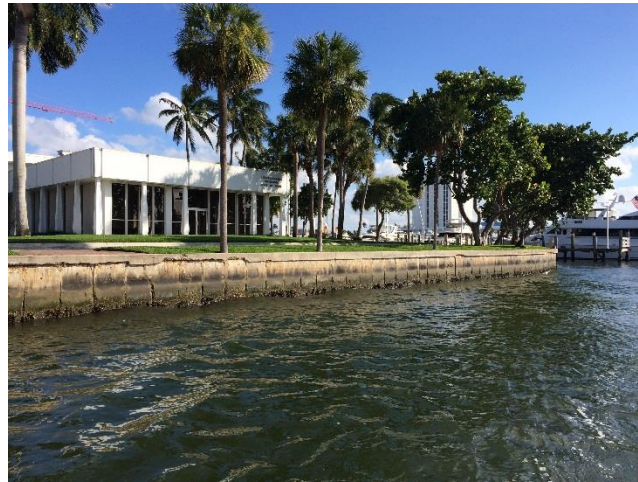
Figure 2.8.2 Seawall No. 19 Supports Parking and Structure Facilities

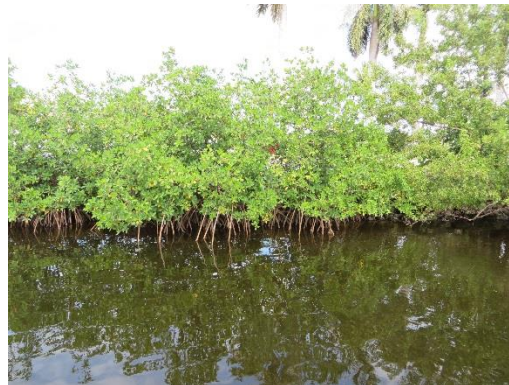
Figure 2.8.3 Mangroves at the North End of Seawall No. 15
