**Memorandum No: 25-054**

**SUBJECT: New Police Headquarters — Phase 2 Peer Review**

**Draft Report**

April 22, 2025  
WJE No. 2024.4855.0

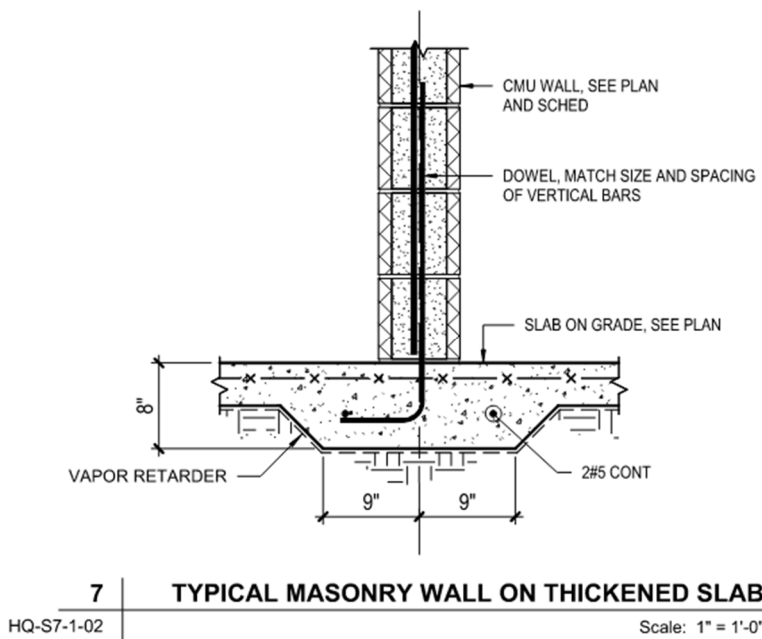
Figure 4. Detail 7 from Sheet HQ-S7-1-02 which shows CMU wall bearing on thickened slab-on-ground. Note that there is a vapor retarder under the slab-on-ground supporting the partition masonry walls

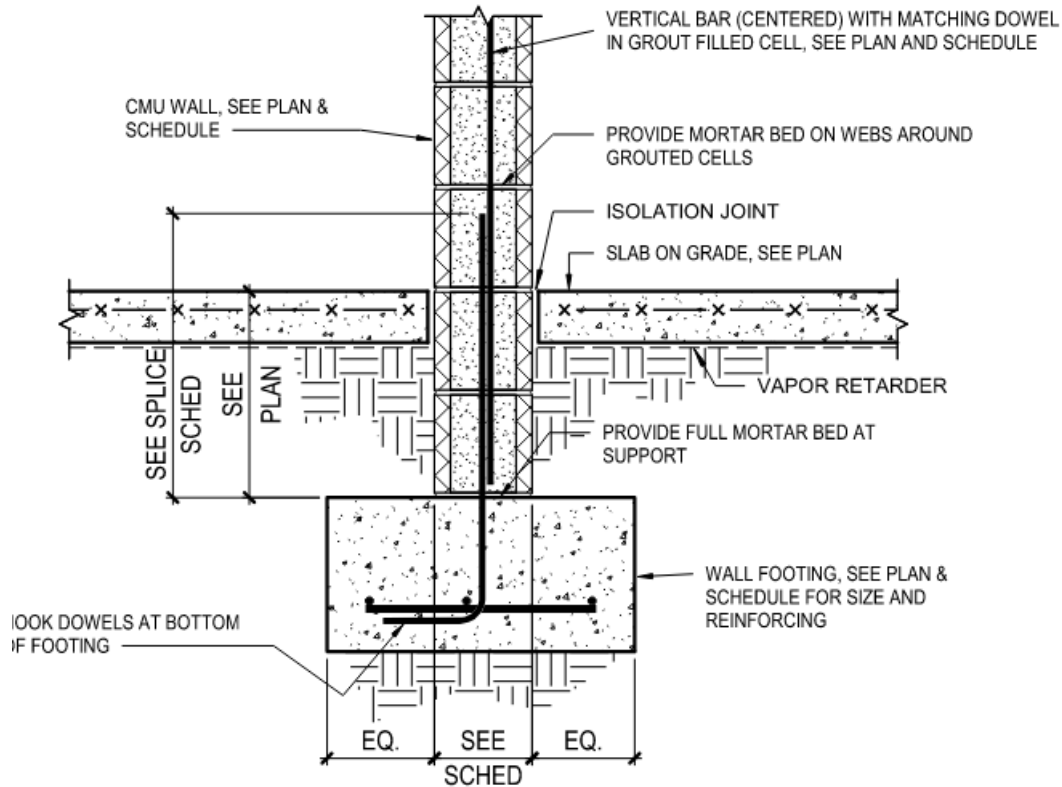
Figure 5. Detail 2 from Sheet HQ-S6-1-03 which shows CMU wall foundation for wall footings that have WF# designation on the foundation plans. Note that the vapor retarder under the slab-on-ground does not pass under the wall footing

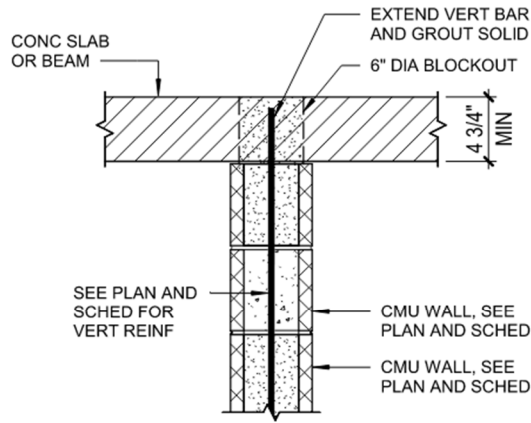
**6** | **TYPICAL TOP OF WALL BRACING - CONCRETE STRUCTURE**  
 HQ-S7-1-02 | Scale: 1" = 1'-0"

None of the connections of the partition masonry walls (i.e., not including the bearing wall in the community room and the masonry core wall in the main structure) to the diaphragm shown in the structural drawings (Detail 6 of Sheet HQ-S7-1-02) or noted in the special inspection reports (i.e., PTA anchors) satisfy ACI 318-14 Section 12.5.3.7. In other words, these connections do not satisfy the shear-friction provisions of ACI 318, which invalidates the masonry walls as code-compliant contributors to lateral resistance.

For the reasons outlined above, we recommend that the SEOR reevaluate the adequacy of the FLPHQ without considering the partition masonry walls as part of the lateral force-resisting system. Note that WJE has *not* considered these partition masonry walls as contributing to the lateral force-resisting system when evaluating the FLPHQ and developing our findings. If the SEOR abandons the approach of attempting to use the partition masonry walls as part of the lateral force-resisting system, then adding the full-height shear wall and rectifying the foundations as noted above in Items 1 and 2, and properly designing them for predicted demands is expected to be sufficient to resolve Item 15.

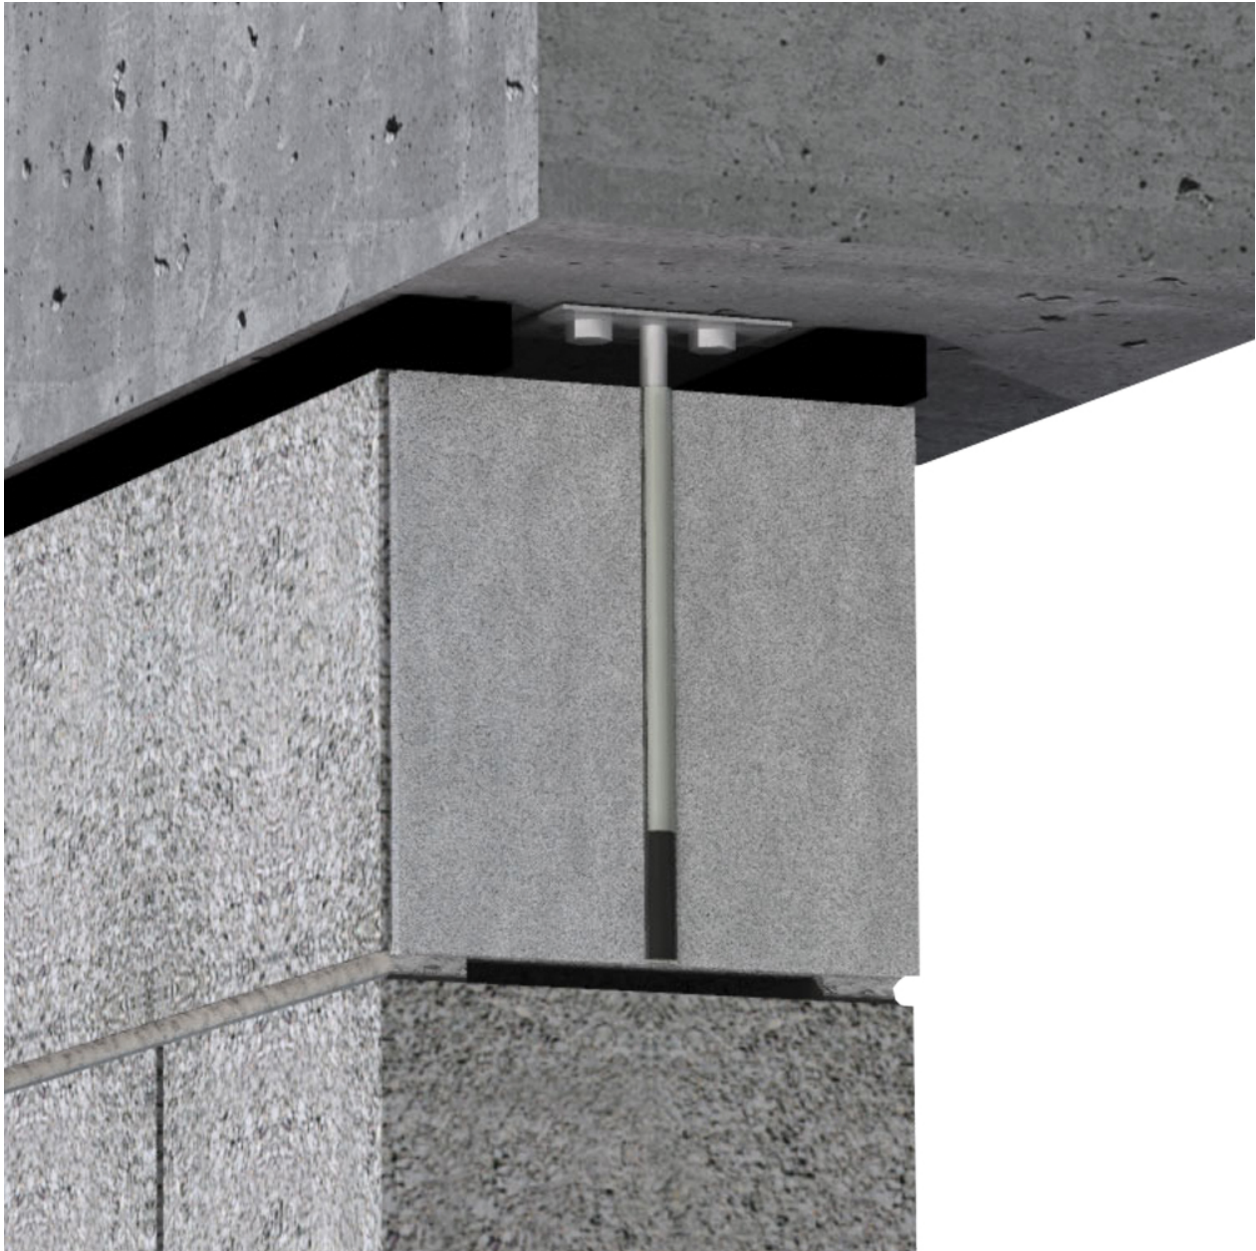
During our review of the special inspection reports, we also observed that the PTA anchors used to connect the partition masonry walls to the above floors were not oriented orthogonal to the walls, as shown on the anchor manufacturer’s website. Accordingly, we recommend that the SEOR comment on which orientation of the anchors is appropriate and provide documentation from the anchor manufacturer supporting the use of that orientation.

Figure 10. Rendering of installed PTA 420 HS anchor from Hohmann and Barnard. Image taken from <https://www.h-b.com/products/pta-series-anchors-pta-420-hs> (accessed on April 13, 2025). Note that the length of the top plate of the anchor is oriented transverse to the length of the wall

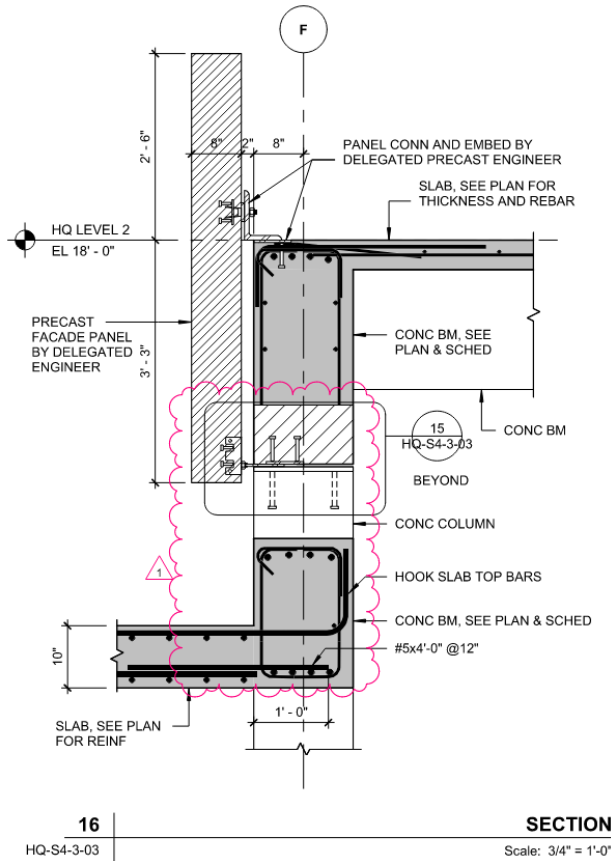
4. **Slide Bearing Capacity.** The bearing stress in the slide bearings on Gridline F (adjoining the community room and lobby area to the main structure of the FLPHQ) exceeds the manufacturer's published allowable capacity when subjected to design loads. Since the design demand exceeds the manufacturer's published design capacity, these bearings are not code-compliant. This condition can be rectified by replacing the existing bearings with a higher-capacity system. Replacement of the bearings may also require rectifications at the top of the stub column below the bearing to accommodate the size and thickness of the new bearing. This rectification should be completed before the building is occupied (0 to 6 months). We also recommend that the SEOR comments on the ranges of temperature and exposure conditions which the slide bearings will be subjected to and how those ranges will affect bearing performance. The SEOR should also provide the peak lateral displacement expected across the slide bearing under factored design level loads and/or thermal temperature differences for review.

Figure 12. Section through joint between Area E and the main building of the FLPHQ showing the lower beam from Area A the stub column above, and the upper beam from the main building of the FLPHQ. The slide bearing is located at the top of the stub column

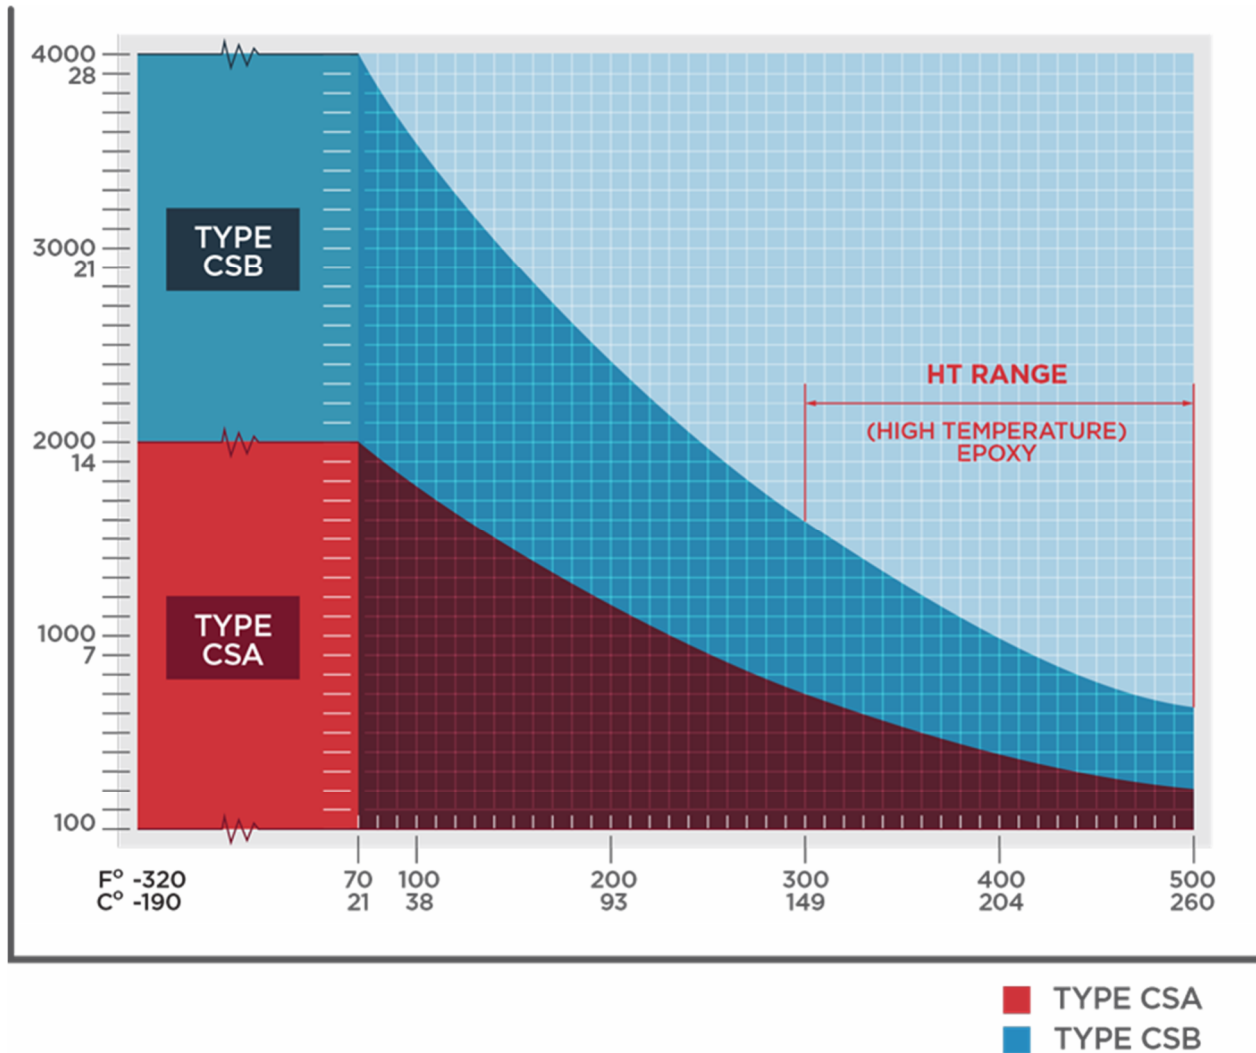
Figure 14. Plot from Con-Serv showing allowable bearing capacity versus temperature. Plot is taken from <https://con-servinc.com/con-slide-bearings-type-csa-csb/> (accessed on April 10, 2025)

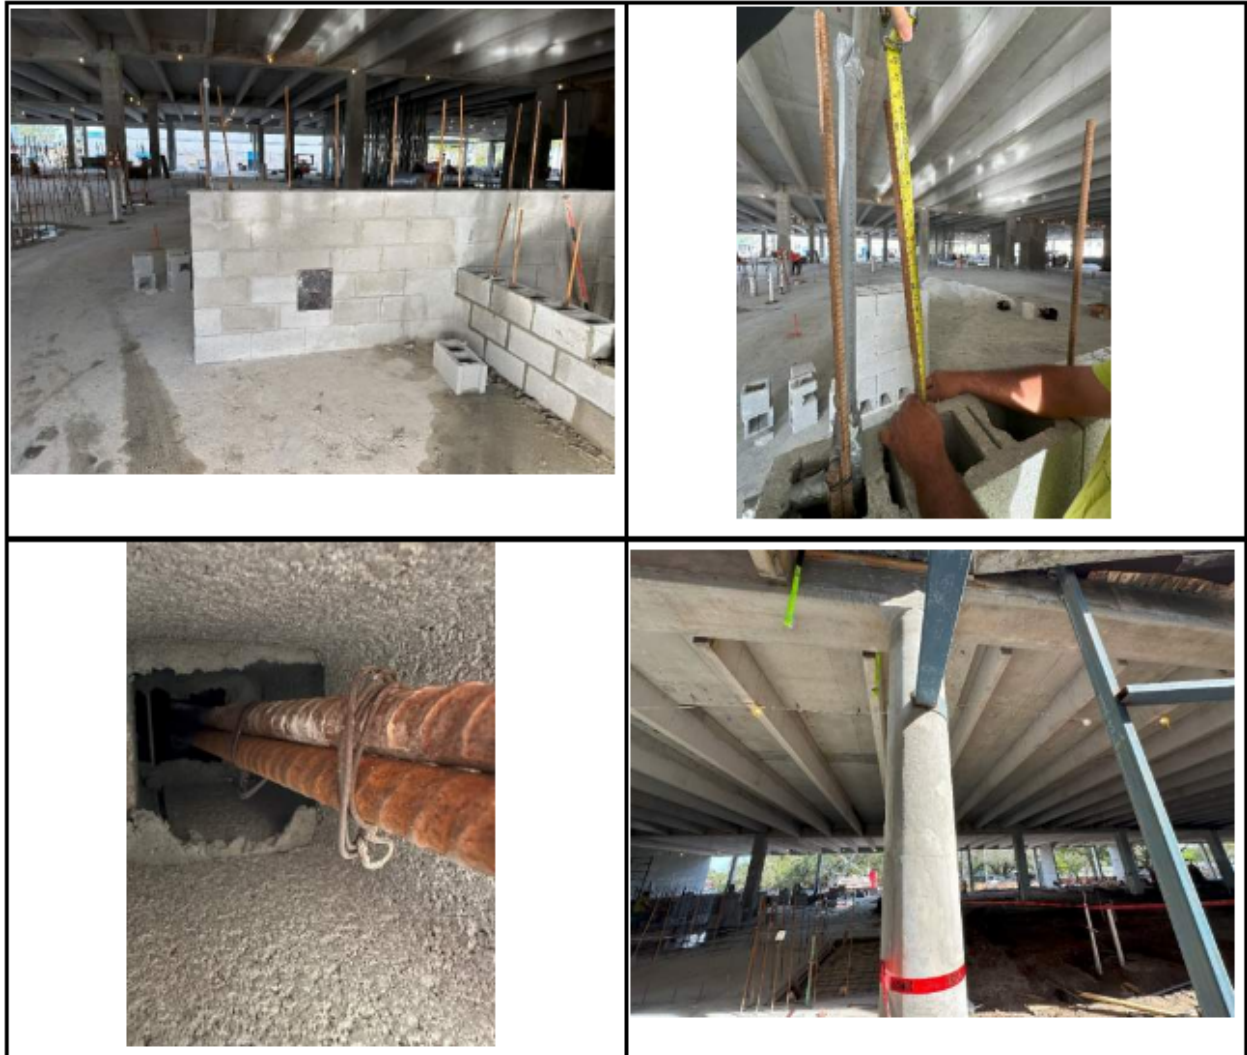
Figure 18. Photographs from Threshold Inspection Report No. 084. Upper photographs and lower right photograph appear to be of the first story prior to full installation of CMU walls. Note the lack of shoring indicating that the CMU walls were not constructed as bearing walls

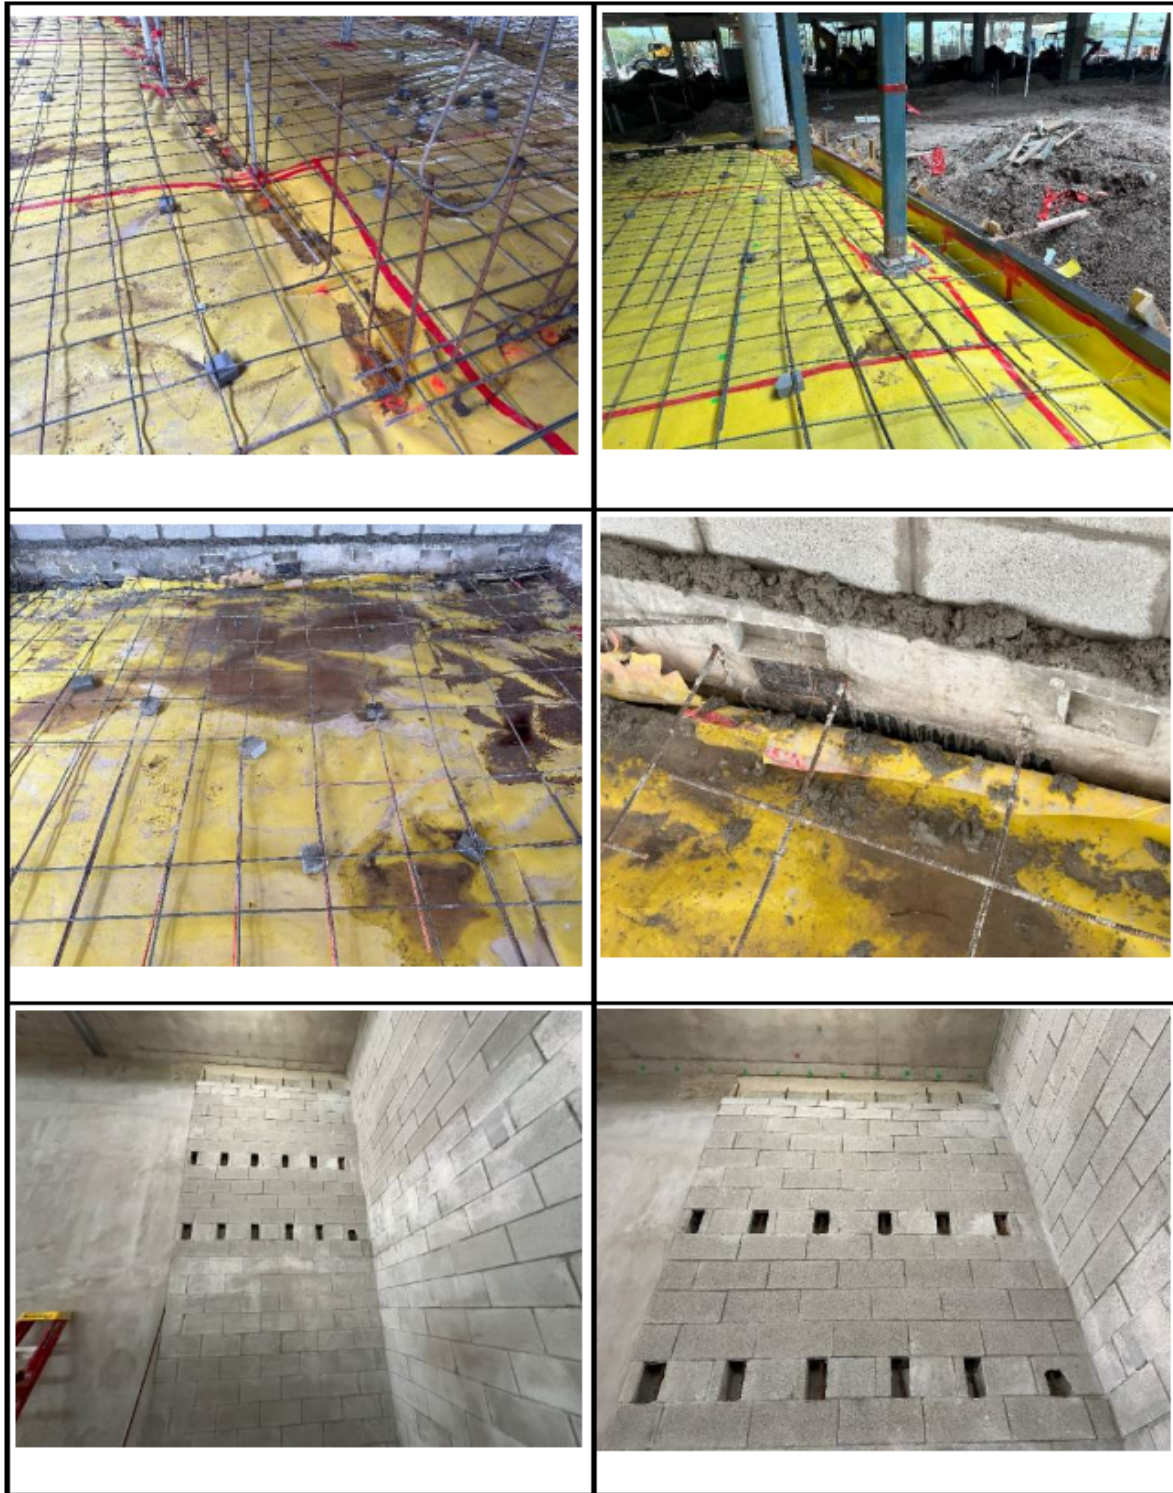
Figure 19. Photographs from Threshold Inspection Report No. 087 showing issue noted by inspector at thickened slab under CMU wall in upper left photograph and reinforcement not extending to the bottom of the slab above in the bottom two photographs

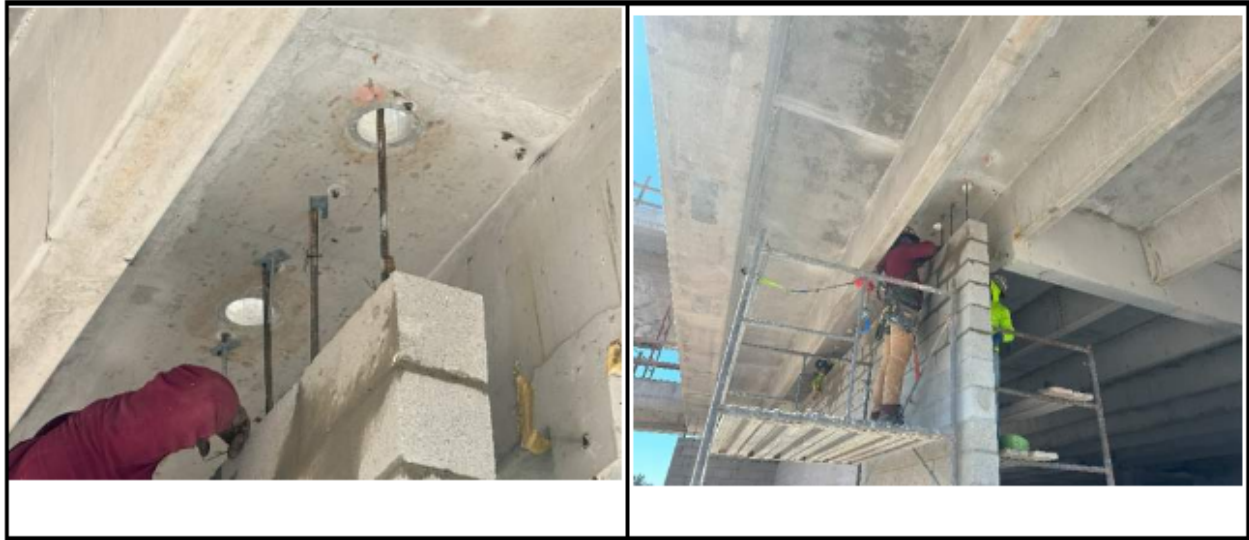
Figure 20. Photographs from Threshold Inspection Report No. 099 showing issue noted by inspector at top of “HQ Level 3 South CMU wall”. Note PTA anchors and connection of vertical masonry bars to above slab in left image. Note that the bars are generally spliced to anchors attached to the slab with screws

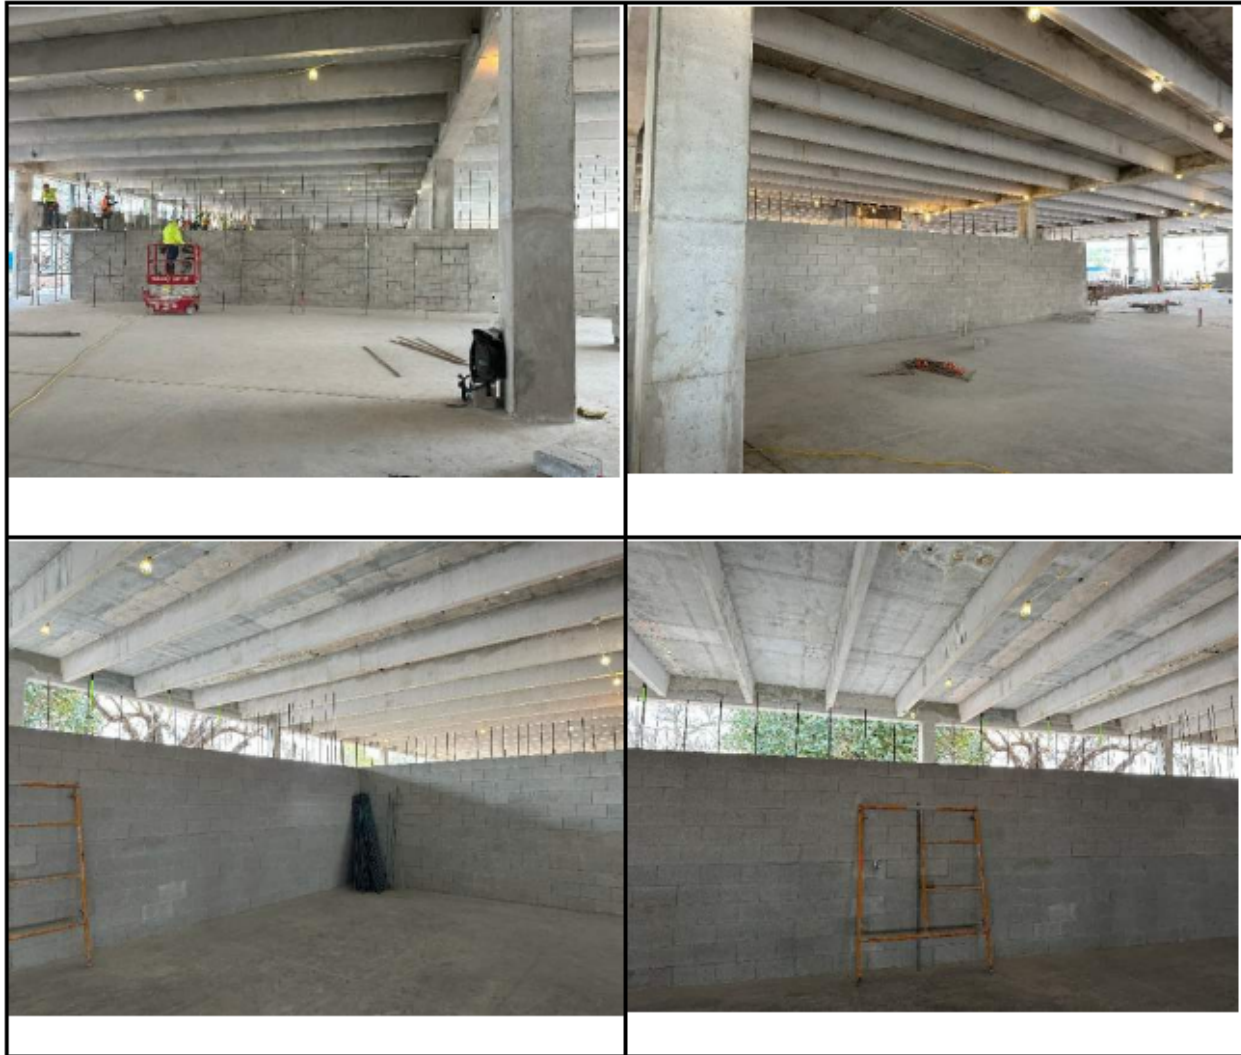
Figure 22. Photographs from Threshold Inspection Report No. 103 showing first story CMU walls under construction. Note the lack of shoring indicating that the CMU walls were not constructed as bearing walls

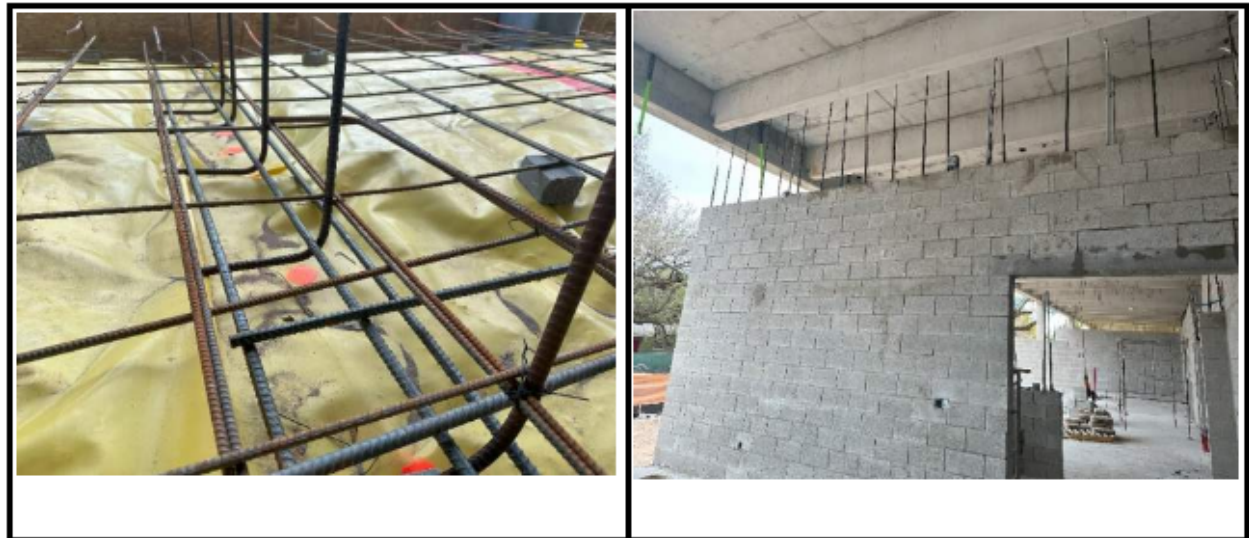
Figure 24. Photographs from Threshold Inspection Report No. 107. The photograph on the left shows hooked dowels at a thickened slab location under a wall. The inspector noted that the dowels needed to be shifted downwards. The photograph on the right shows a CMU wall in the first story under construction. Note that no shoring of the structure above is present, indicating that the CMU wall was not constructed as a bearing wall

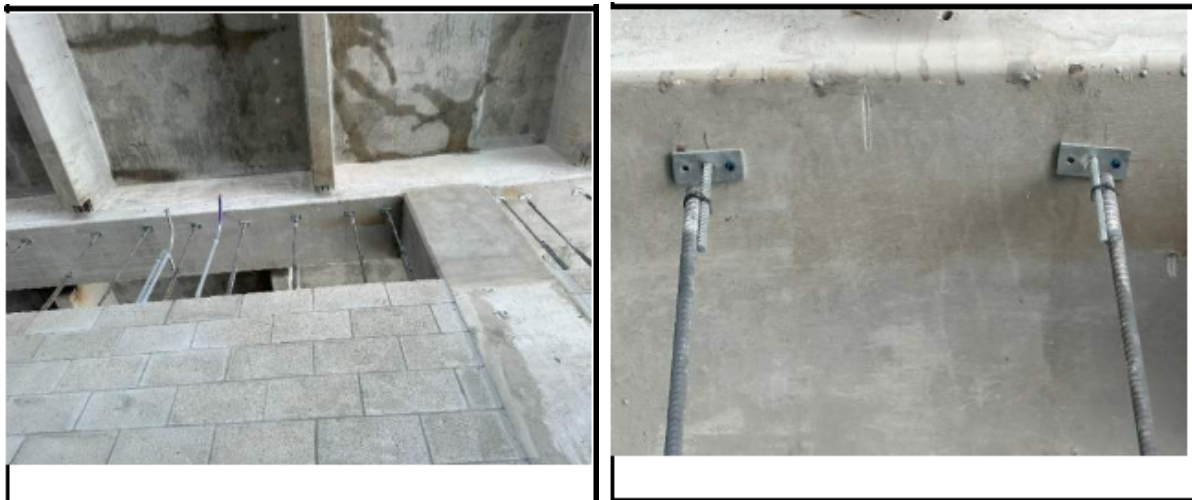
Figure 26. Photographs from Threshold Inspection Report No. 123 showing PTA connectors at bottom of soffit beam with only one screw attaching the plate of the anchor to the soffit beam

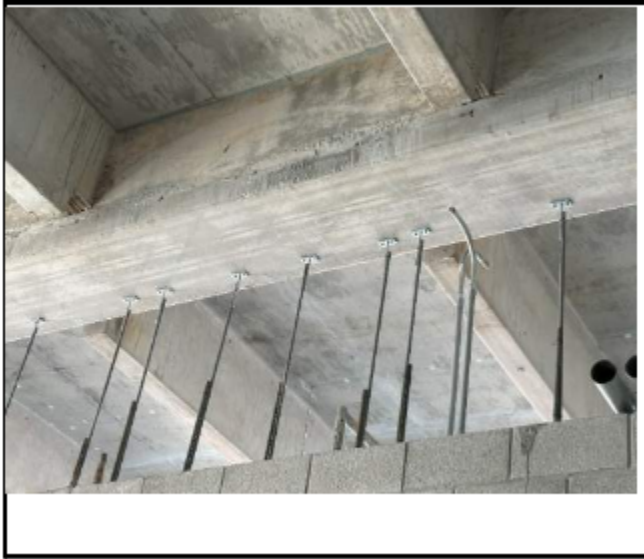
Figure 27. Photograph from Threshold Inspection Report No. 125 showing PTA connectors at bottom of soffit beam with the two screws attaching the plate of the anchor to the soffit beam

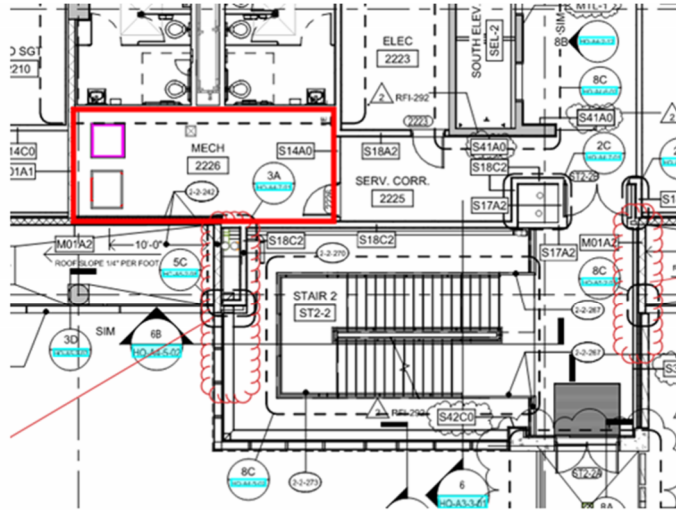
14. **Mechanical Equipment.** In addition to the loading discrepancy noted in Item 8 above regarding equipment weight versus uniform live loads, there is an area bounded by Gridlines H, J, 14, and 16 on Level 2 that is designated in the architectural drawings, but not in the structural drawings, as

Figure 30. Possible inconsistency between architectural drawings (top) and structural drawings (bottom) regarding the location of mechanical equipment. Note that the architectural drawings designate Room 2226 on Level 2 as a mechanical room; however, the structural drawings indicate that a General live load rather than a Mechanical live load was used to design that area

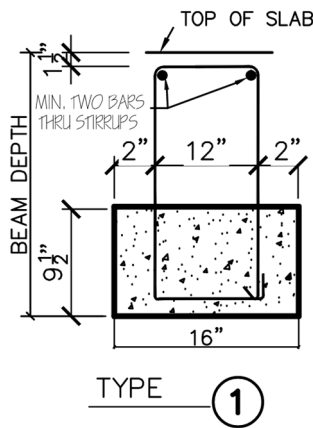
Figure 31. Cross-section of soffit beam (Sheet SC-3C-D of Submittal 328) showing 1.5 inches of cover to the transverse reinforcement

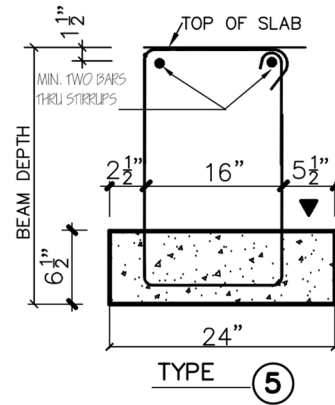
Figure 32. Cross-section of soffit beam (Sheet SC-3C-D of Submittal 328) showing approximately zero inches of cover to the transverse reinforcement

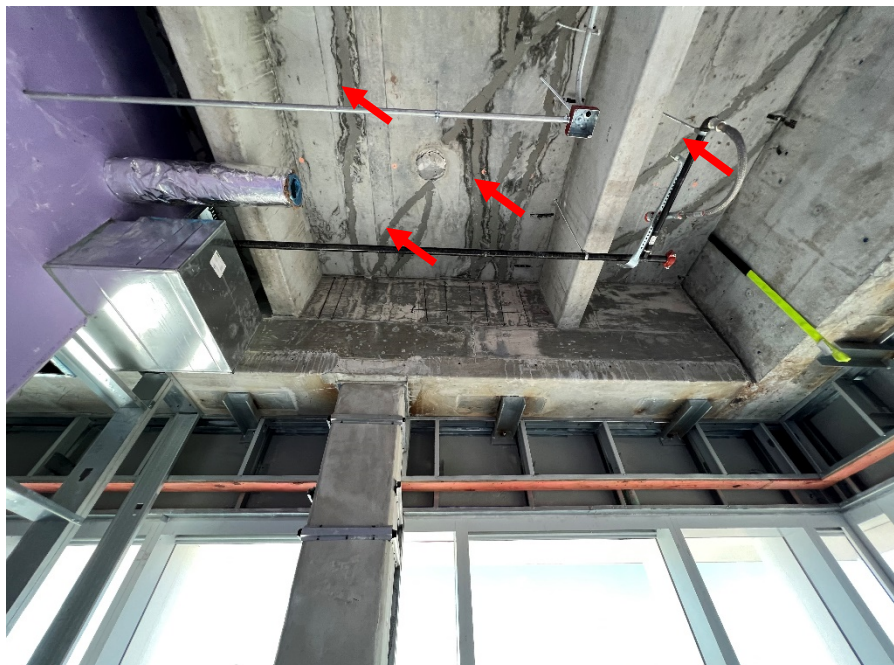
Figure 33. Example of cracks (see red arrows) in the reinforced concrete slab (at the roof) which have been repaired

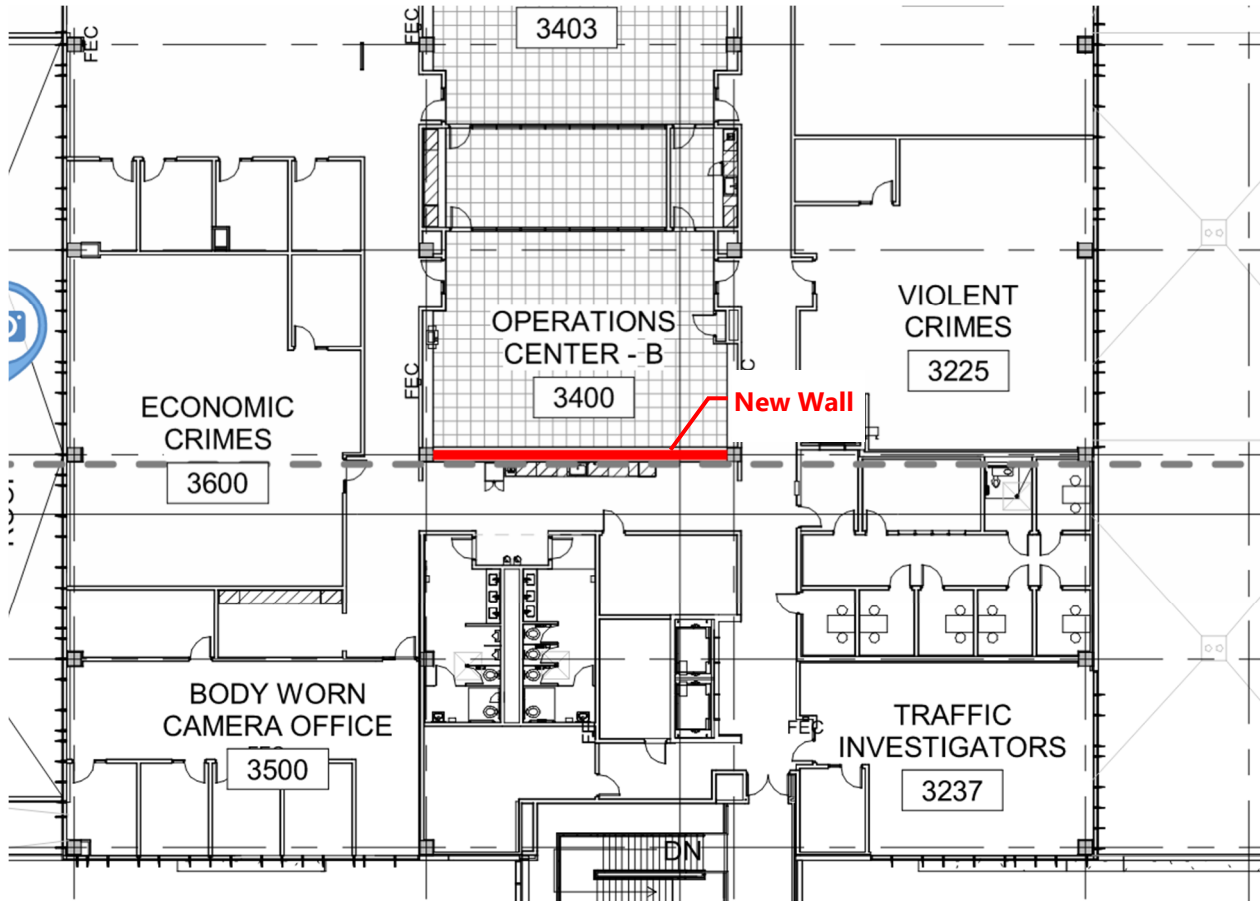
1. **Shear Wall Capacities.** The southern-most reinforced concrete core wall is not code-compliant for one-way shear strength or flexural strength between Levels 1 and 2. Adding a properly designed full-height shear wall (i.e., from foundation to roof) with an accompanying foundation to the structure on Gridline 14 between Gridlines H and J can rectify this condition. Rectification of this condition should be carried out *as soon as possible* (0 to 2 months) and should be completed before the building is occupied. Note that, contrary to the position of the SEOR, we do *not* believe that the concrete masonry unit (CMU) partition walls are a reliable part of the lateral load-resisting system. We have provided other findings related to the use of these CMU walls in the Documentation section below.

Figure 40. One potential location for the proposed new reinforced concrete shear wall

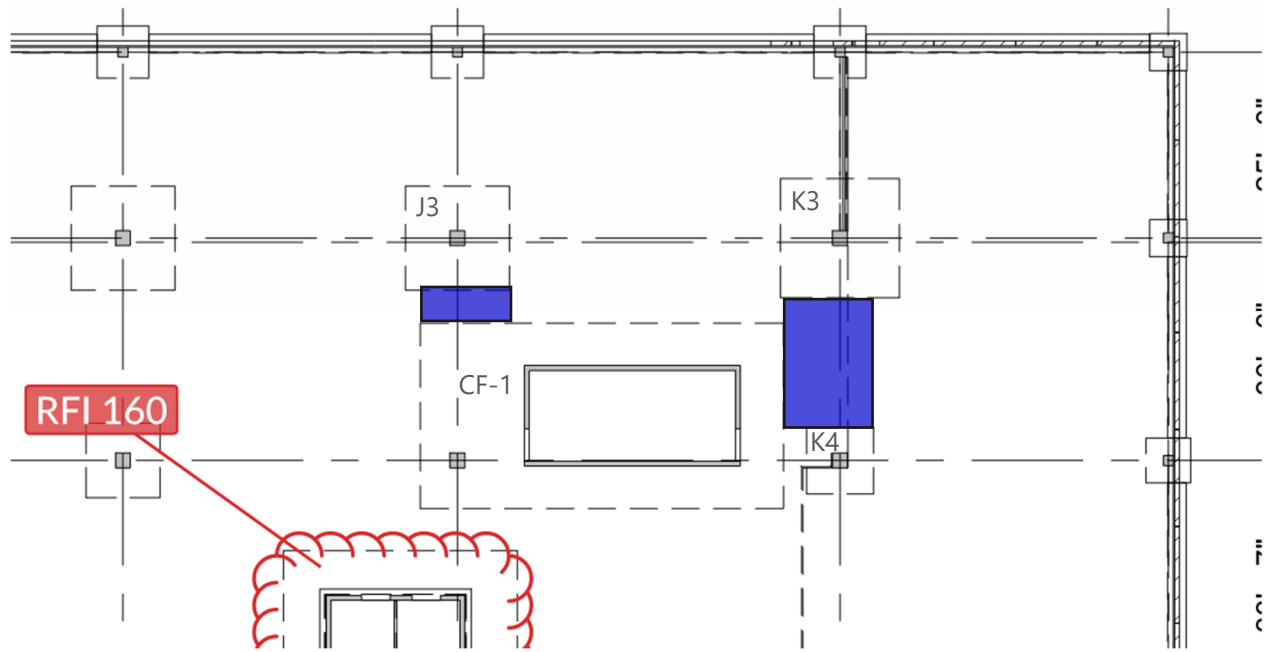
2. **Foundation Capacities at Shear Walls.** The mat foundations for the concrete shear walls around the north stair shaft (designated as CF-1 on the structural drawings) and the south elevator shaft (CF-3) all have lateral demands that exceed the allowable design capacity under design wind loads in the east-west direction and are therefore not code-compliant. Adding the aforementioned shear wall to the building can rectify conditions related to the south elevator shaft but not the sliding exceedance at the north stair shaft. Attaching mat footing CF-1 to its surrounding isolated

footings can rectify the sliding condition. Rectifications to the foundations should take place at the same time as those for the shear walls.

Figure 41. Conceptual rectification of sliding deficiency of mat footing CF-1. The mat footing is attached to nearby isolated footings (J3, K3, and K4) with new reinforced concrete (shown in blue font)
