**SUBJECT: Police Headquarters WJE Clarification Letter – Phase 2 Peer Review Report – Life Safety Category**

**Draft Report**

April 22, 2025  
WJE No. 2024.4855.0

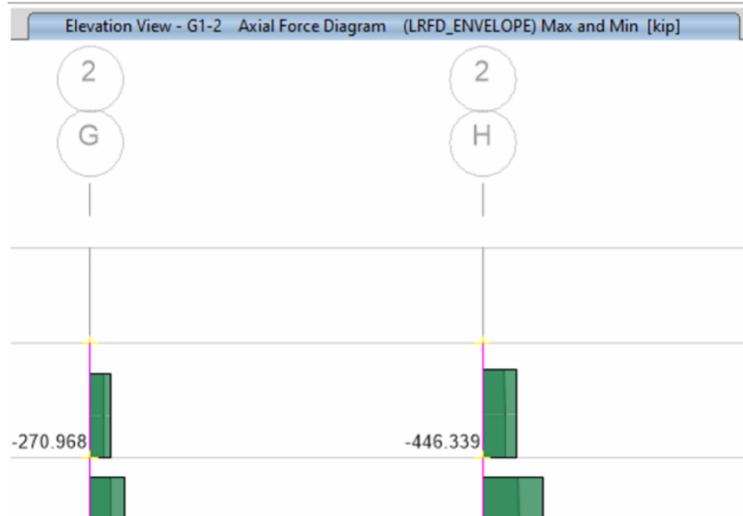
Figure 3. Image from the file "2025311\_FLP Column H-2 and J-2 Validation.pdf" (dated March 11, 2025) prepared by the SEOR which indicates that they used a flexural stiffness modifier of 0.35 for reinforced concrete columns along Gridline 2

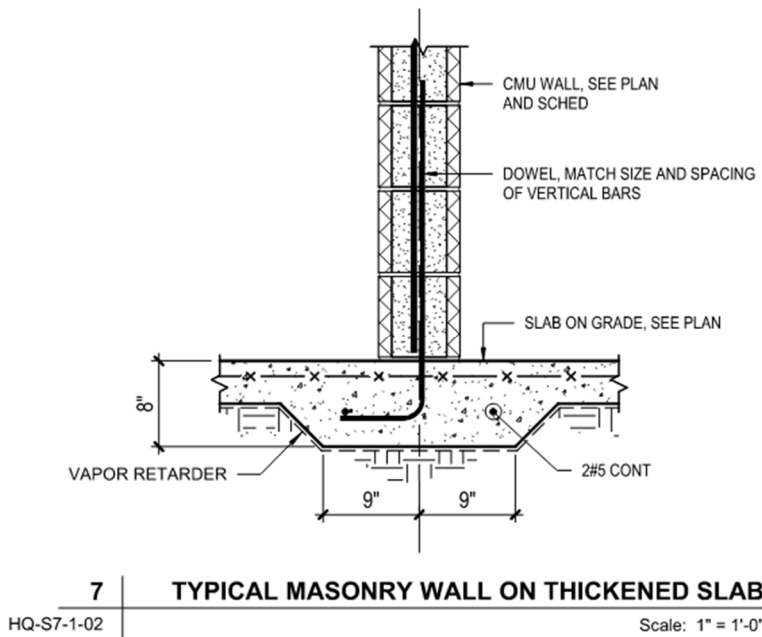
Figure 4. Detail 7 from Sheet HQ-S7-1-02 which shows CMU wall bearing on thickened slab-on-ground. Note that there is a vapor retarder under the slab-on-ground supporting the partition masonry walls

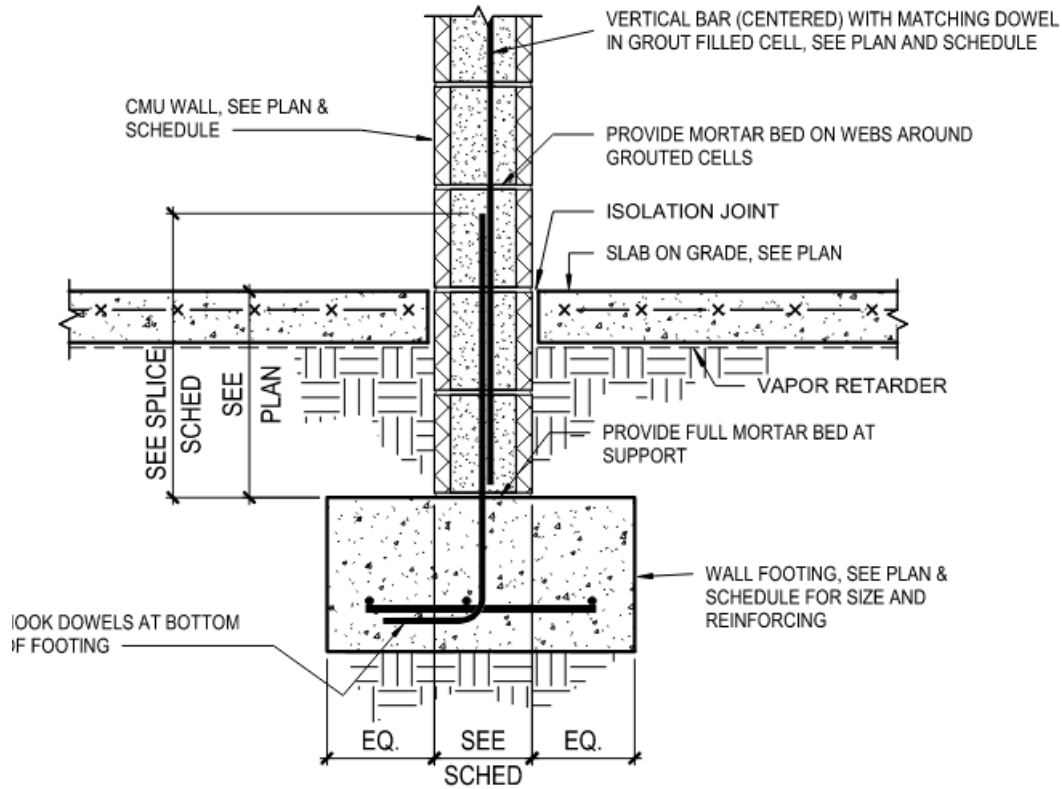
Figure 5. Detail 2 from Sheet HQ-S6-1-03 which shows CMU wall foundation for wall footings that have WF# designation on the foundation plans. Note that the vapor retarder under the slab-on-ground does not pass under the wall footing

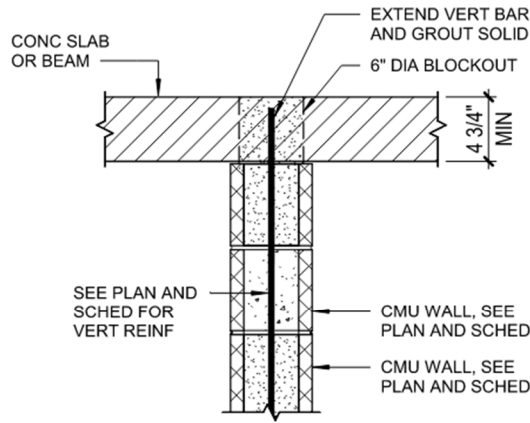
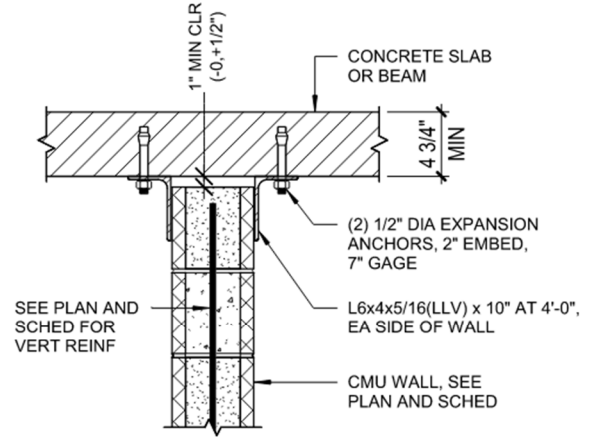
**6** | **TYPICAL TOP OF WALL BRACING - CONCRETE STRUCTURE**  
 HQ-S7-1-02 | Scale: 1" = 1'-0"

None of the connections of the partition masonry walls (i.e., not including the bearing wall in the community room and the masonry core wall in the main structure) to the diaphragm shown in the structural drawings (Detail 6 of Sheet HQ-S7-1-02) or noted in the special inspection reports (i.e., PTA anchors) satisfy ACI 318-14 Section 12.5.3.7. In other words, these connections do not satisfy the shear-friction provisions of ACI 318, which invalidates the masonry walls as code-compliant contributors to lateral resistance.

For the reasons outlined above, we recommend that the SEOR reevaluate the adequacy of the FLPHQ without considering the partition masonry walls as part of the lateral force-resisting system. Note that WJE has *not* considered these partition masonry walls as contributing to the lateral force-resisting system when evaluating the FLPHQ and developing our findings. If the SEOR abandons the approach of attempting to use the partition masonry walls as part of the lateral force-resisting system, then adding the full-height shear wall and rectifying the foundations as noted above in Items 1 and 2, and properly designing them for predicted demands is expected to be sufficient to resolve Item 15.

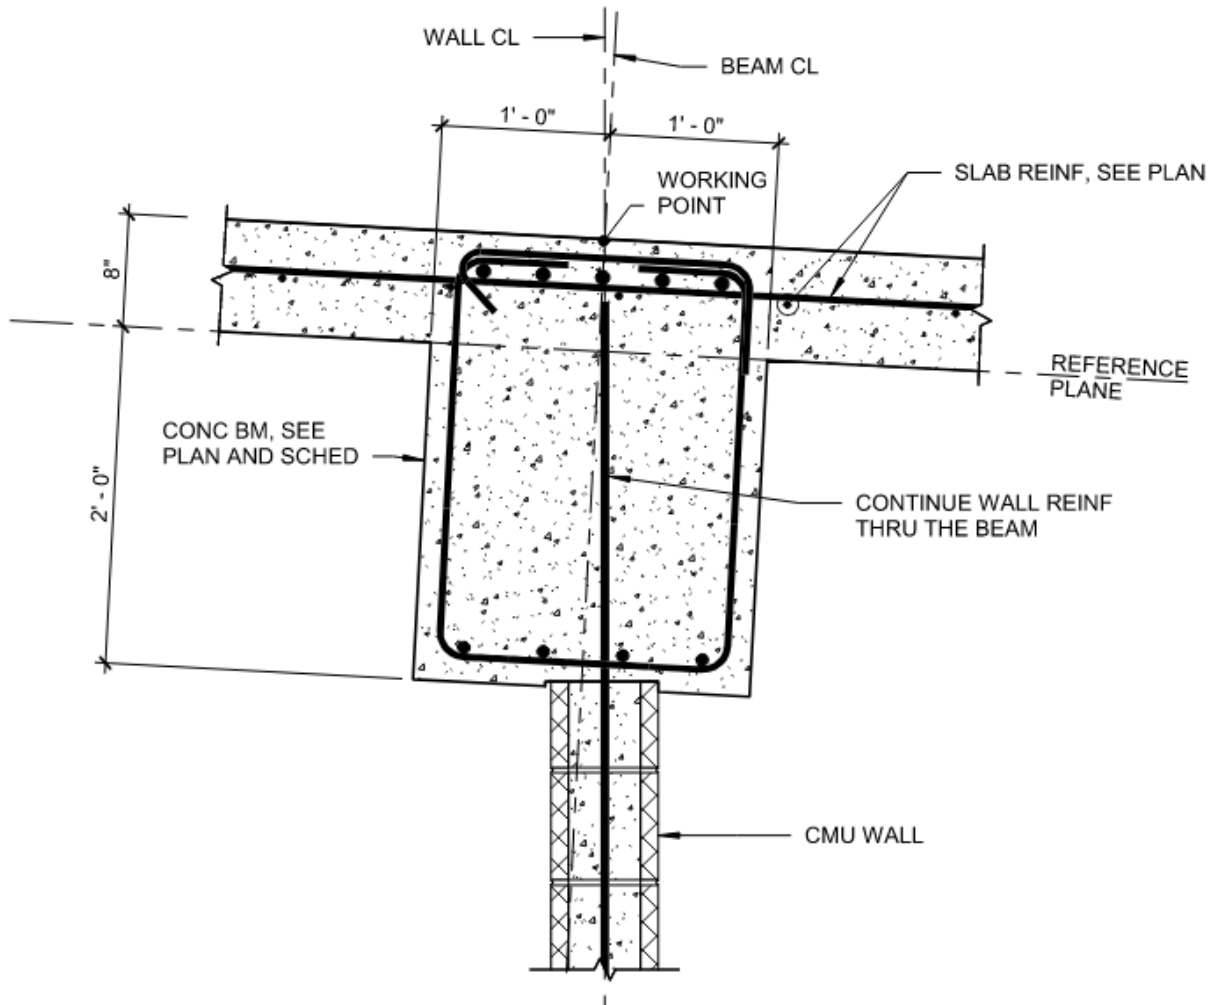
Figure 11. Detail 3 from Sheet HQ-S4-3-04, dated November 15, 2023 showing connection between top of CMU wall and reinforced concrete beam overhead in Area E. Note that the vertical wall reinforcement is well-anchored above the CMU wall to permit shear forces from the diaphragm to be transferred into the wall through shear friction

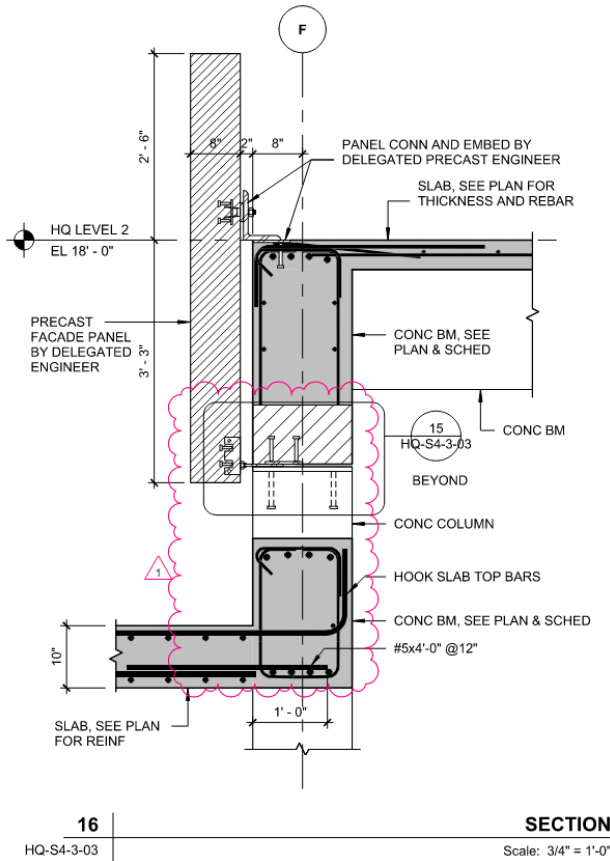
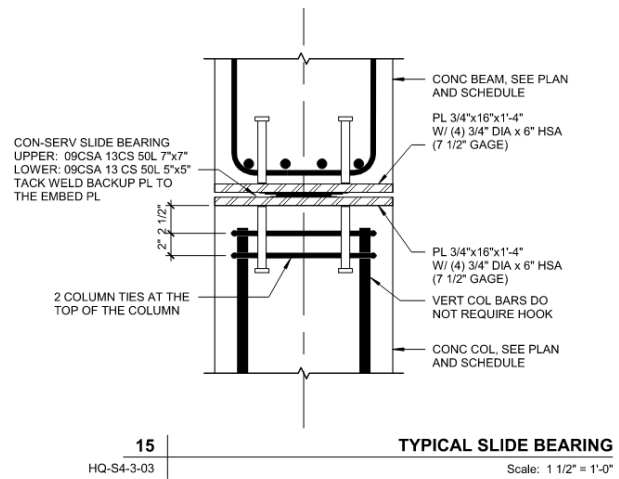
4. **Slide Bearing Capacity.** The bearing stress in the slide bearings on Gridline F (adjoining the community room and lobby area to the main structure of the FLPHQ) exceeds the manufacturer's published allowable capacity when subjected to design loads. Since the design demand exceeds the manufacturer's published design capacity, these bearings are not code-compliant. This condition can be rectified by replacing the existing bearings with a higher-capacity system. Replacement of the bearings may also require rectifications at the top of the stub column below the bearing to accommodate the size and thickness of the new bearing. This rectification should be completed before the building is occupied (0 to 6 months). We also recommend that the SEOR comments on the ranges of temperature and exposure conditions which the slide bearings will be subjected to and how those ranges will affect bearing performance. The SEOR should also provide the peak lateral displacement expected across the slide bearing under factored design level loads and/or thermal temperature differences for review.

Figure 12. Section through joint between Area E and the main building of the FLPHQ showing the lower beam from Area A the stub column above, and the upper beam from the main building of the FLPHQ. The slide bearing is located at the top of the stub column

Figure 13. Detail of slide bearing noting the manufacturer (Con-Serv) and the size of the lower portion of the bearing (5 inches by 5 inches)

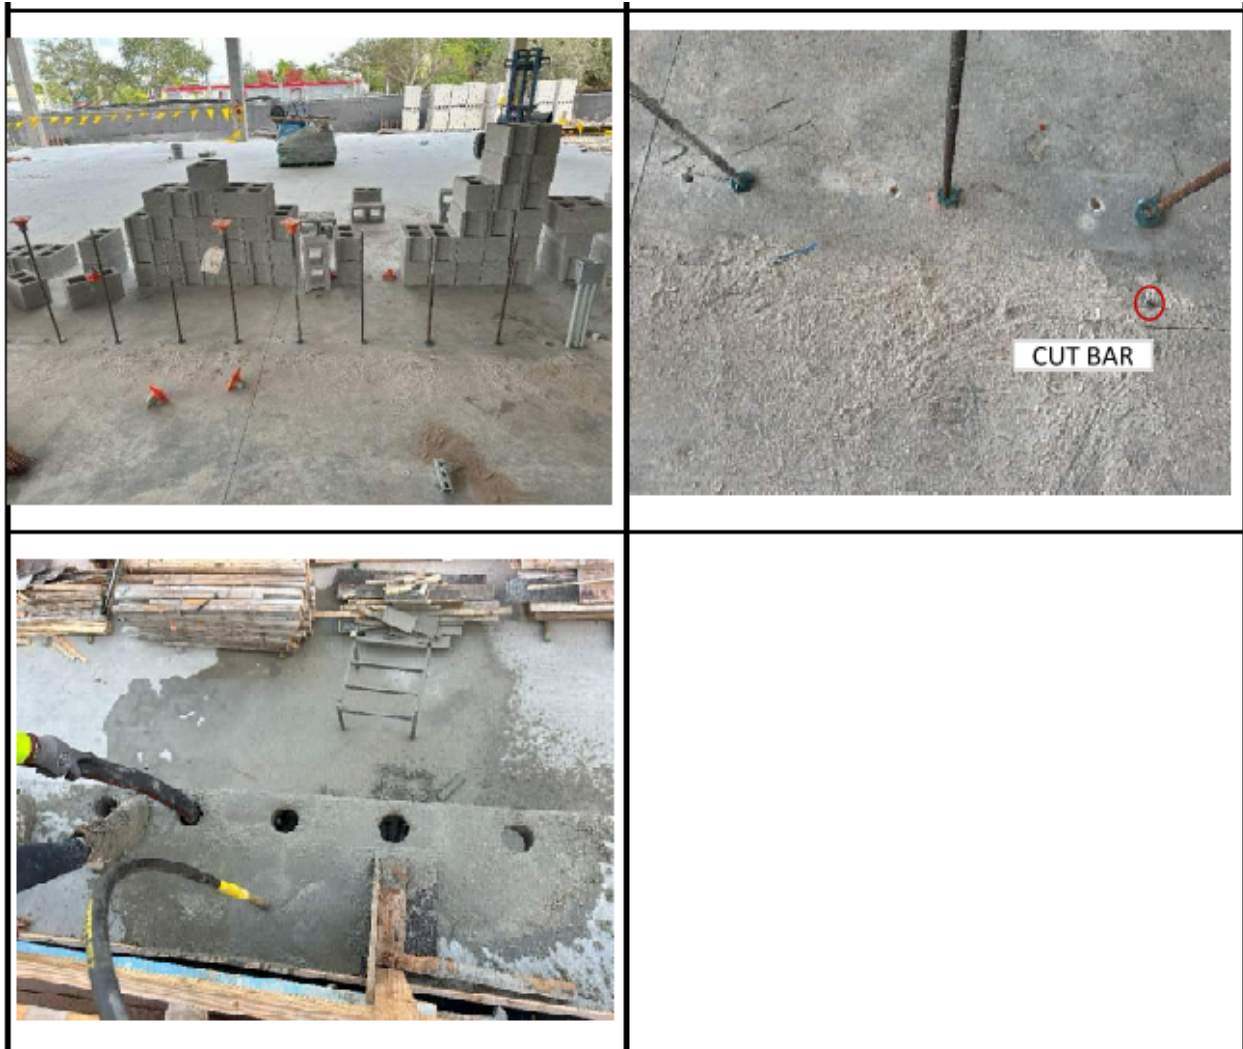
Figure 16. Photographs from Threshold Inspection Report No. 073 showing bars doweled 3 inches into slab-on-ground after original bars were mislocated (top photographs), and filling of grouted cells (bottom photograph)

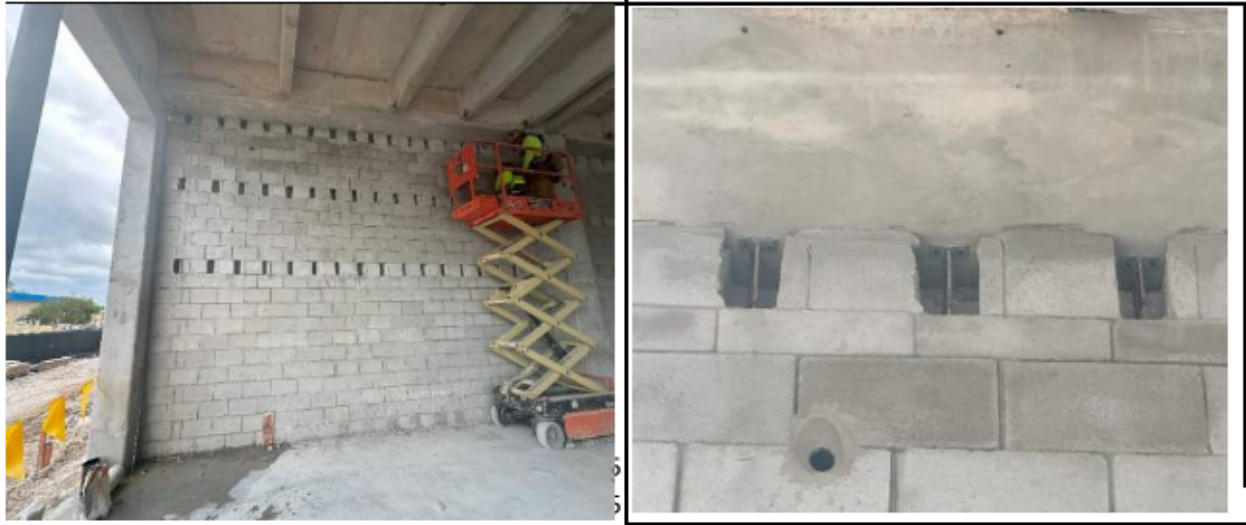
Figure 17. Photographs from Threshold Inspection Report No. 081. Left photograph shows overall wall construction on first story at one location. Right photograph shows the PTA anchors at the top of the wall. Note that two screws are used to connect each anchor to the above element

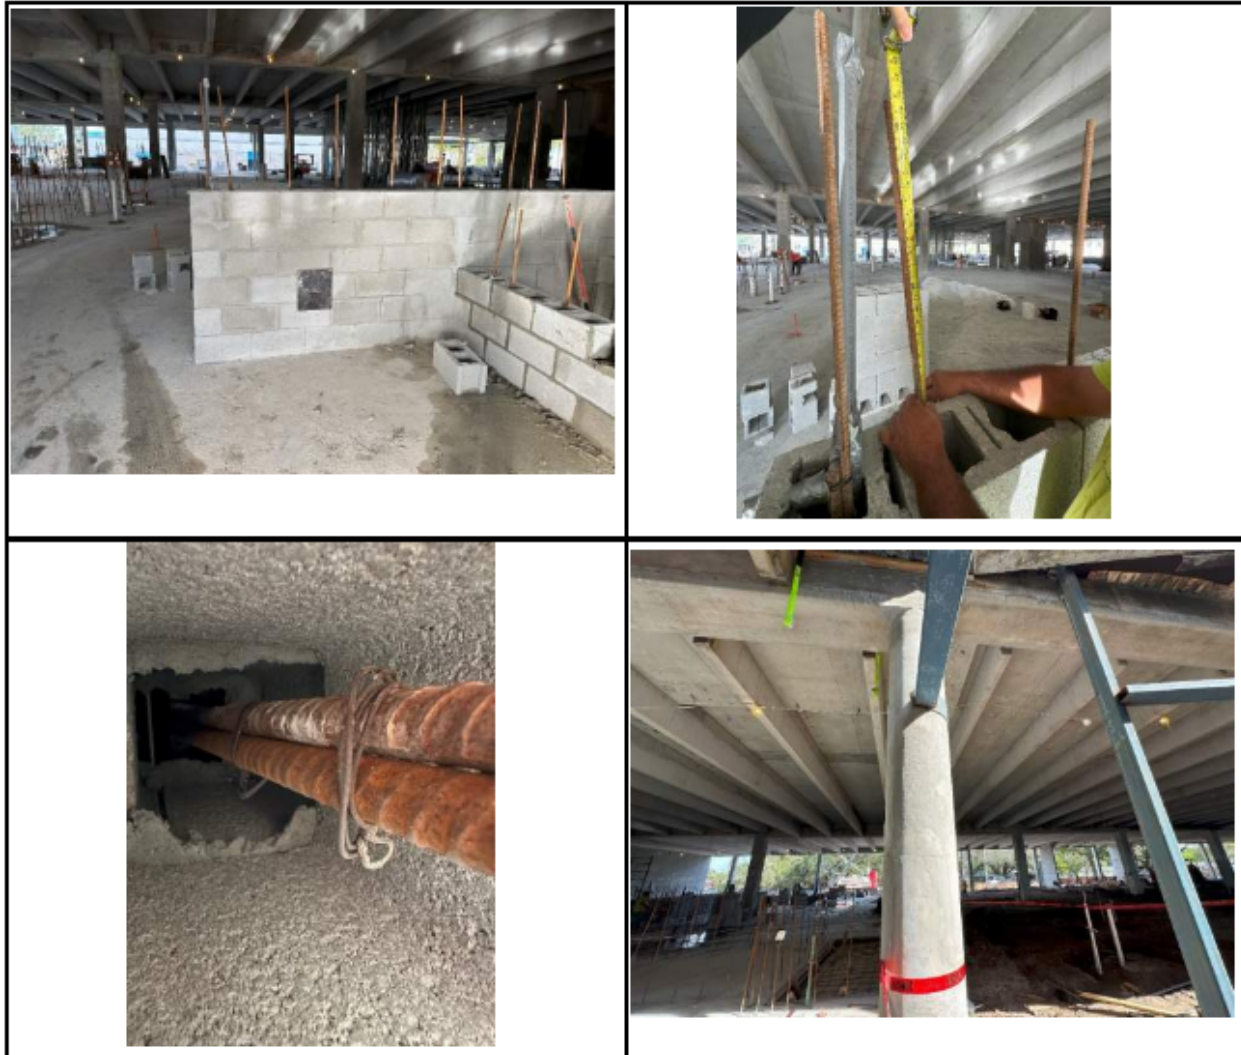
Figure 18. Photographs from Threshold Inspection Report No. 084. Upper photographs and lower right photograph appear to be of the first story prior to full installation of CMU walls. Note the lack of shoring indicating that the CMU walls were not constructed as bearing walls

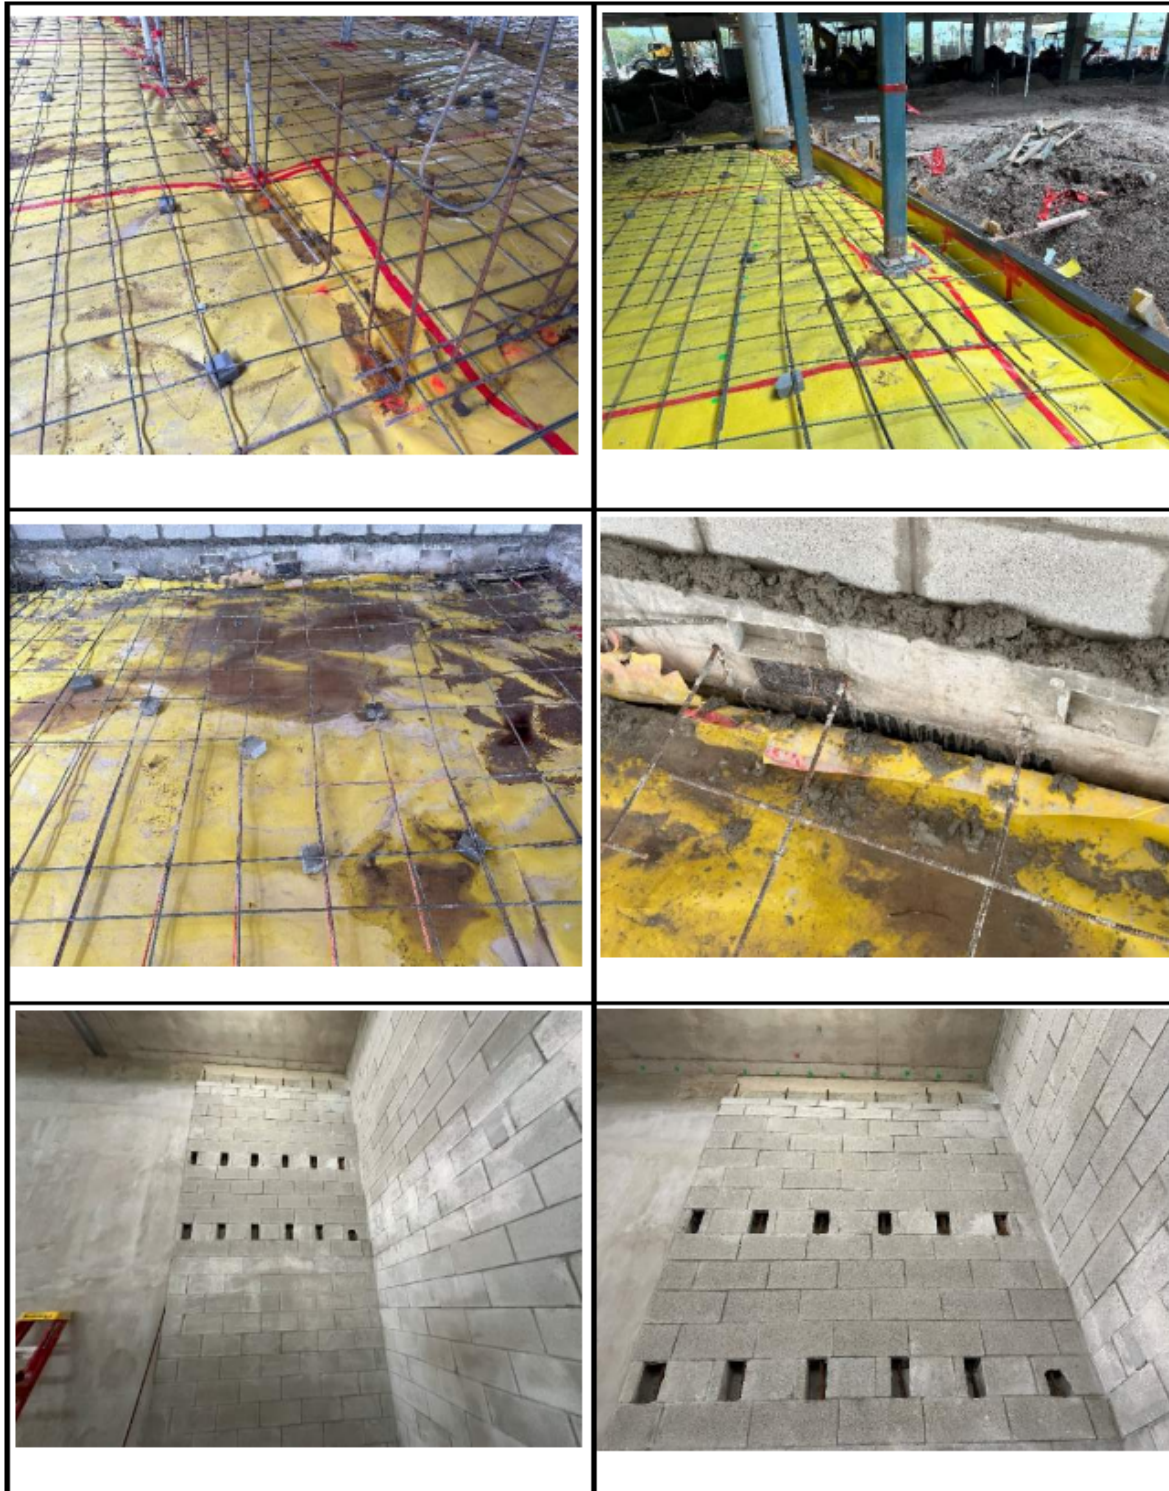
Figure 19. Photographs from Threshold Inspection Report No. 087 showing issue noted by inspector at thickened slab under CMU wall in upper left photograph and reinforcement not extending to the bottom of the slab above in the bottom two photographs

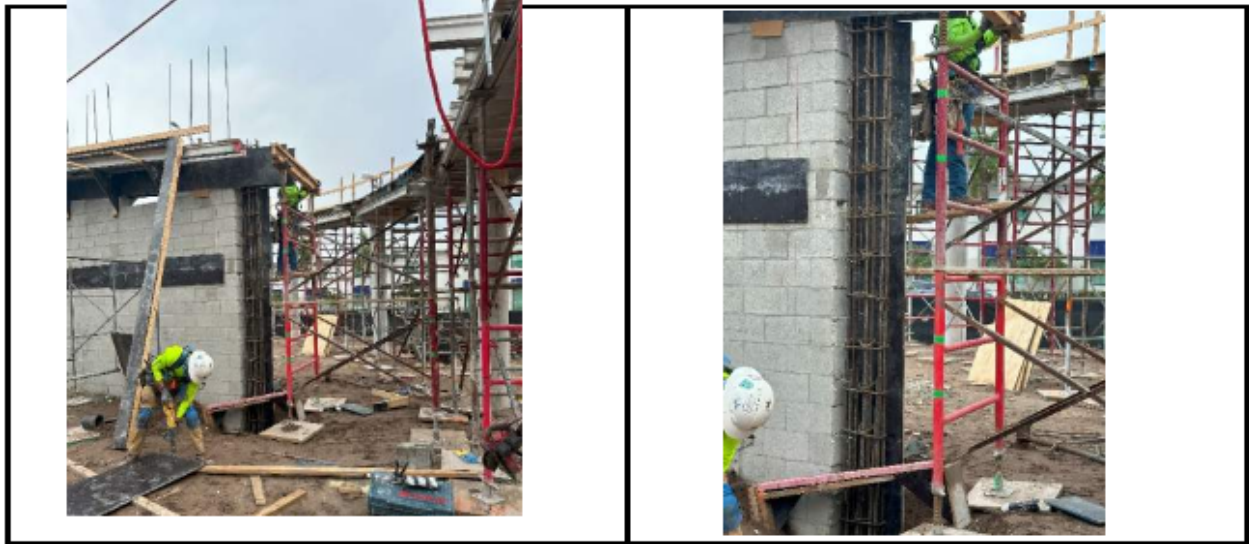
Figure 23. Photographs from Threshold Inspection Report No. 105 showing CMU wall in Area E under construction. Since the wall is being constructed prior to the roof structure, this CMU wall will take load from the roof structure as a bearing wall

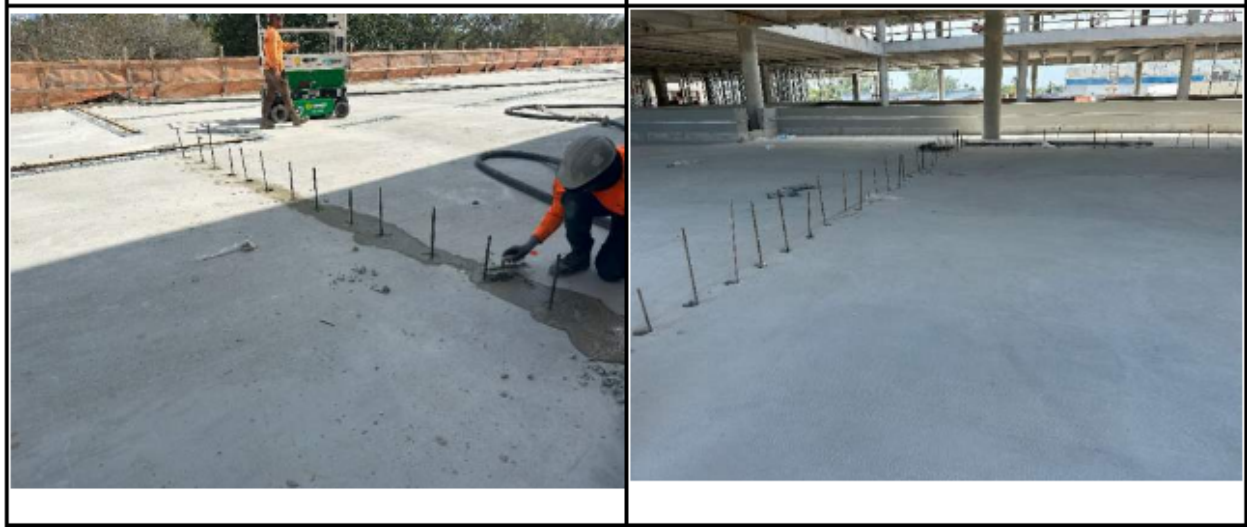
Figure 25. Photographs from Threshold Inspection Report No. 109 showing dowels extending through cored holes in slab. These dowels appear to be from the CMU wall below

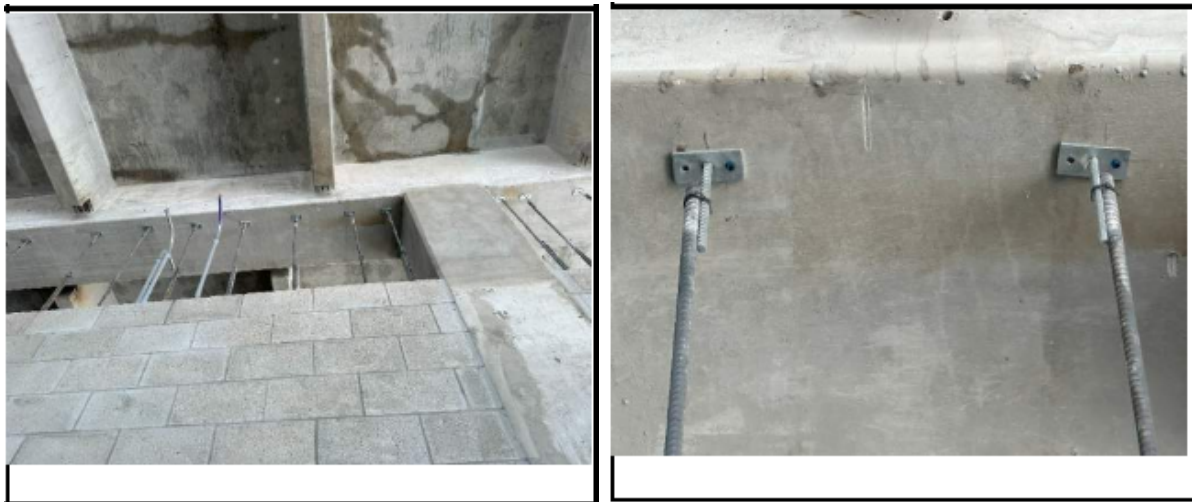
During our review of the special inspection reports, we also observed that the PTA anchors used to connect the partition masonry walls to the above floors were not oriented orthogonal to the walls, as shown on the anchor manufacturer's website. Accordingly, we recommend that the SEOR comment on which orientation of the anchors is appropriate and provide documentation from the anchor manufacturer supporting the use of that orientation.

Figure 26. Photographs from Threshold Inspection Report No. 123 showing PTA connectors at bottom of soffit beam with only one screw attaching the plate of the anchor to the soffit beam

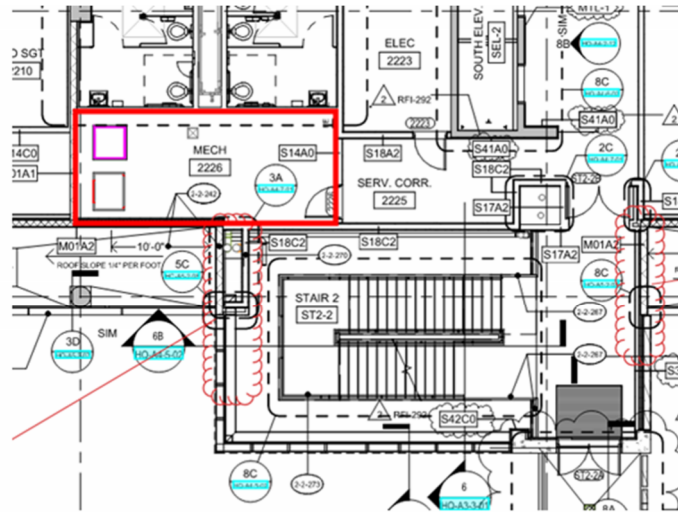
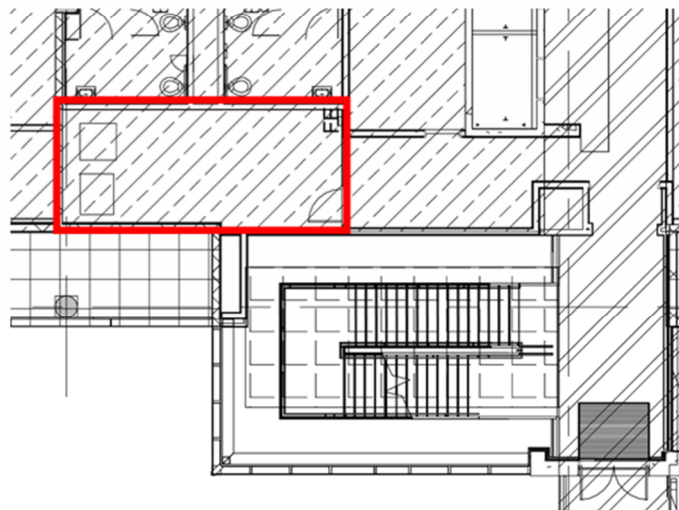
14. **Mechanical Equipment.** In addition to the loading discrepancy noted in Item 8 above regarding equipment weight versus uniform live loads, there is an area bounded by Gridlines H, J, 14, and 16 on Level 2 that is designated in the architectural drawings, but not in the structural drawings, as

Figure 30. Possible inconsistency between architectural drawings (top) and structural drawings (bottom) regarding the location of mechanical equipment. Note that the architectural drawings designate Room 2226 on Level 2 as a mechanical room; however, the structural drawings indicate that a General live load rather than a Mechanical live load was used to design that area

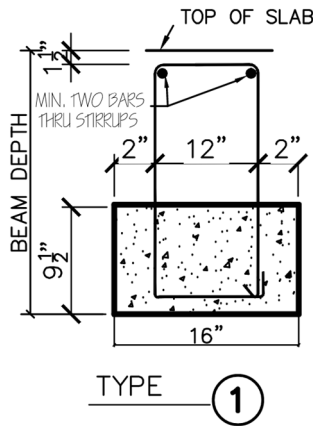
Figure 31. Cross-section of soffit beam (Sheet SC-3C-D of Submittal 328) showing 1.5 inches of cover to the transverse reinforcement

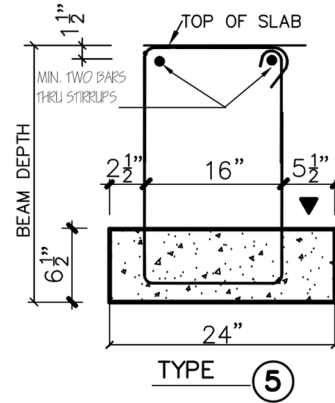
Figure 32. Cross-section of soffit beam (Sheet SC-3C-D of Submittal 328) showing approximately zero inches of cover to the transverse reinforcement

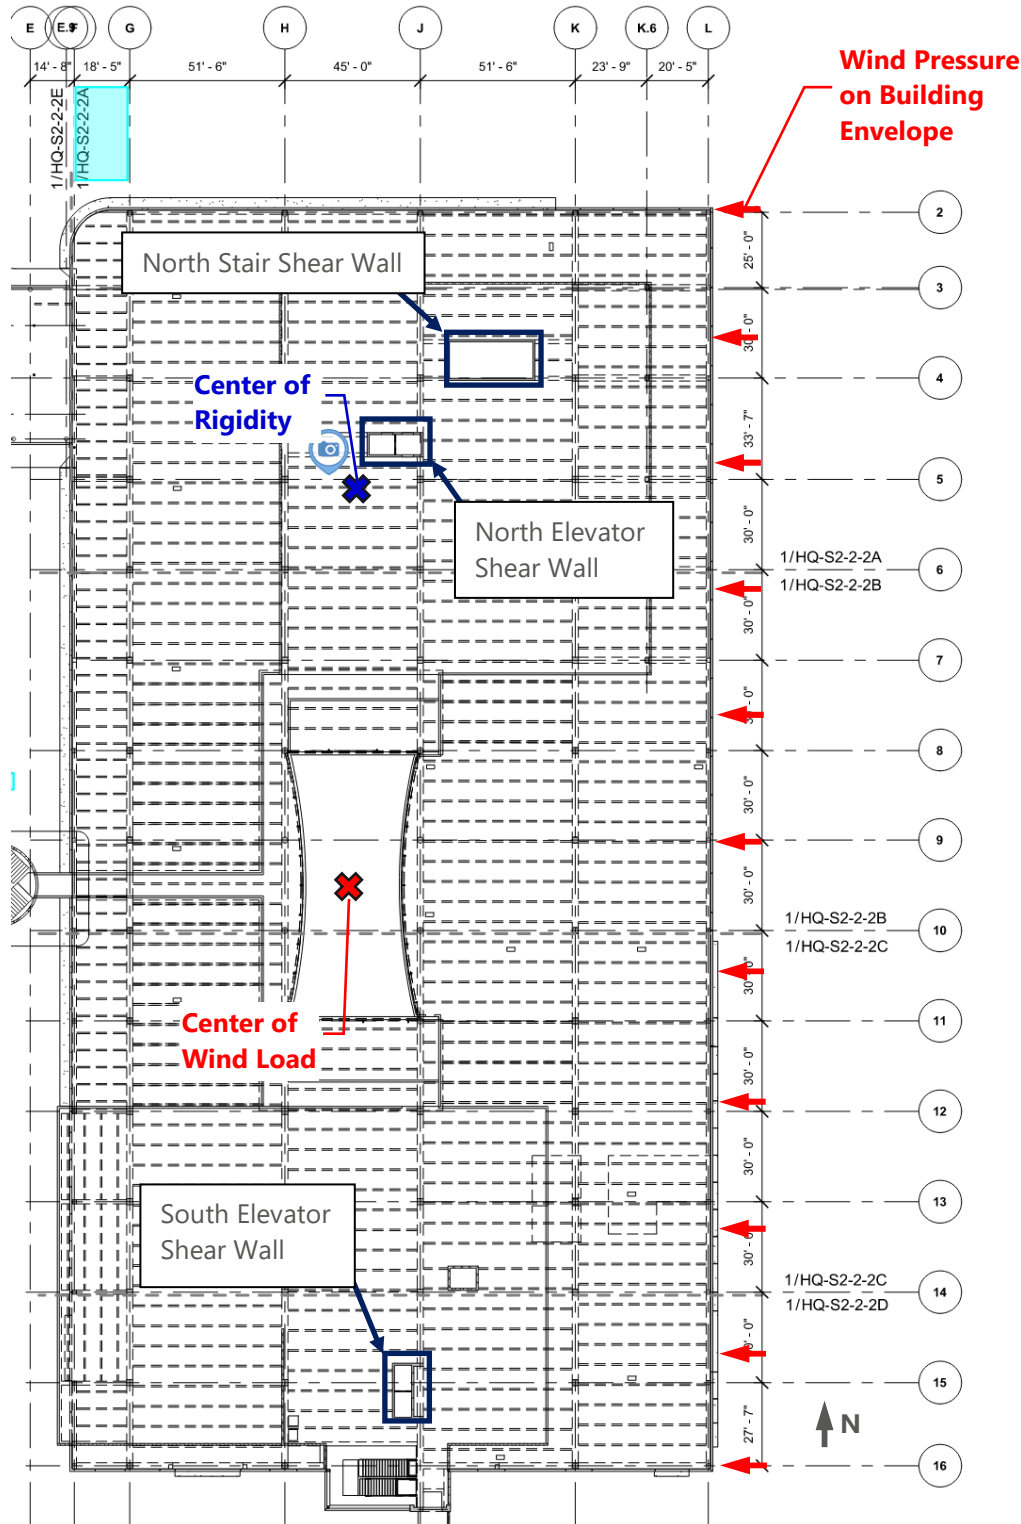
Figure 34. Plan view of FLP HQ showing the approximate locations of the center of rigidity and east-west wind loads. Due to eccentricity between the two, the structure twists

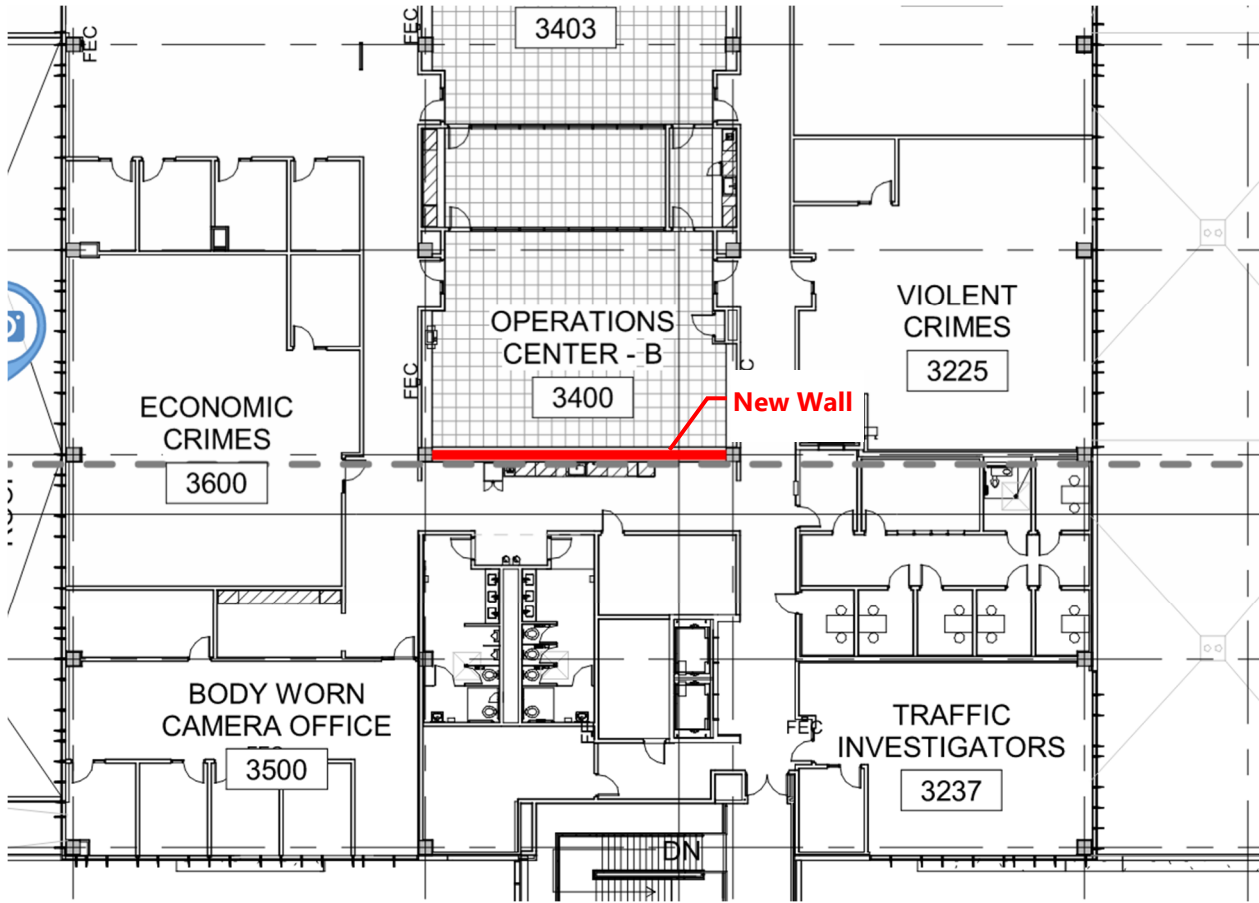
1. **Shear Wall Capacities.** The southern-most reinforced concrete core wall is not code-compliant for one-way shear strength or flexural strength between Levels 1 and 2. Adding a properly designed full-height shear wall (i.e., from foundation to roof) with an accompanying foundation to the structure on Gridline 14 between Gridlines H and J can rectify this condition. Rectification of this condition should be carried out *as soon as possible* (0 to 2 months) and should be completed before the building is occupied. Note that, contrary to the position of the SEOR, we do *not* believe that the concrete masonry unit (CMU) partition walls are a reliable part of the lateral load-resisting system. We have provided other findings related to the use of these CMU walls in the Documentation section below.

Figure 40. One potential location for the proposed new reinforced concrete shear wall

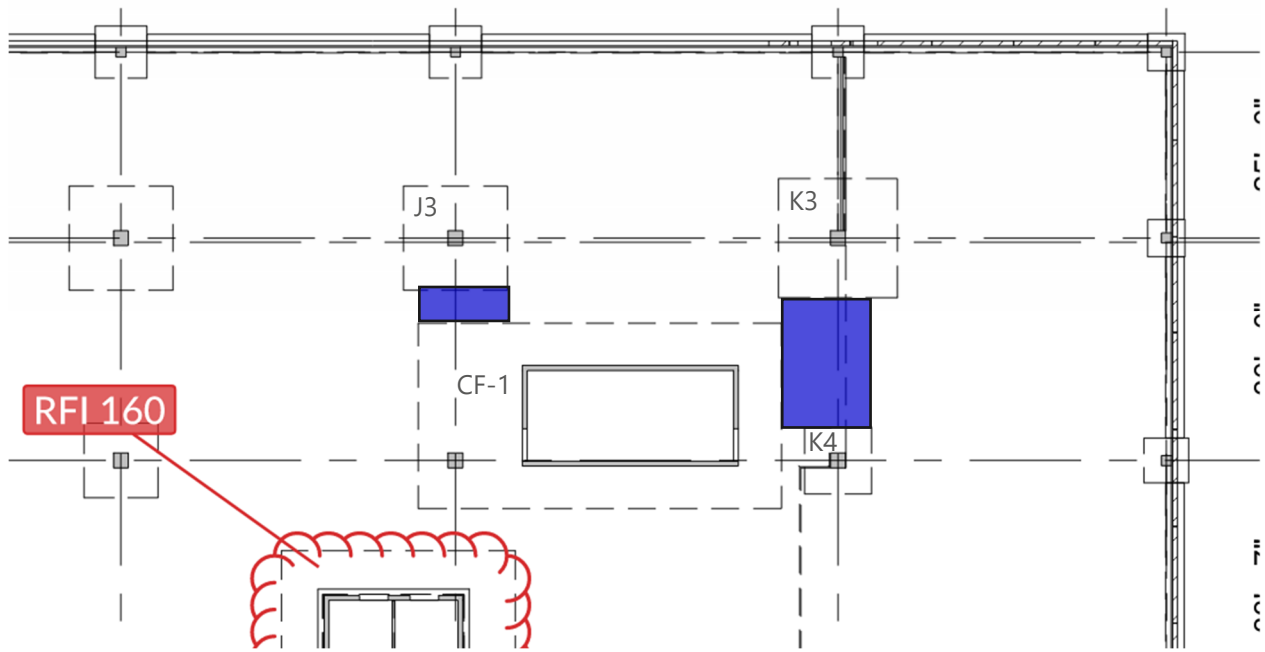
2. **Foundation Capacities at Shear Walls.** The mat foundations for the concrete shear walls around the north stair shaft (designated as CF-1 on the structural drawings) and the south elevator shaft (CF-3) all have lateral demands that exceed the allowable design capacity under design wind loads in the east-west direction and are therefore not code-compliant. Adding the aforementioned shear wall to the building can rectify conditions related to the south elevator shaft but not the sliding exceedance at the north stair shaft. Attaching mat footing CF-1 to its surrounding isolated

footings can rectify the sliding condition. Rectifications to the foundations should take place at the same time as those for the shear walls.

Figure 41. Conceptual rectification of sliding deficiency of mat footing CF-1. The mat footing is attached to nearby isolated footings (J3, K3, and K4) with new reinforced concrete (shown in blue font)
