Bridge & Seawall Infrastructure Review

Public Works – Engineering Division

February 3, 2020

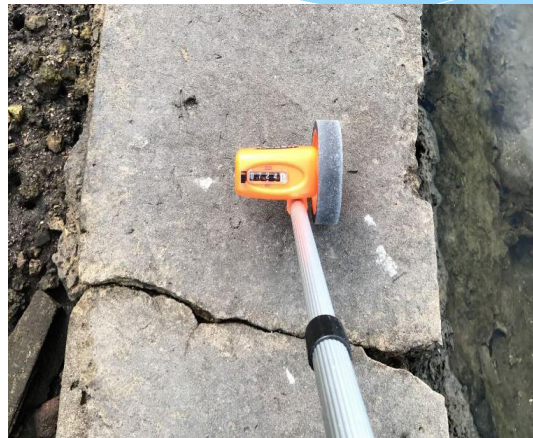
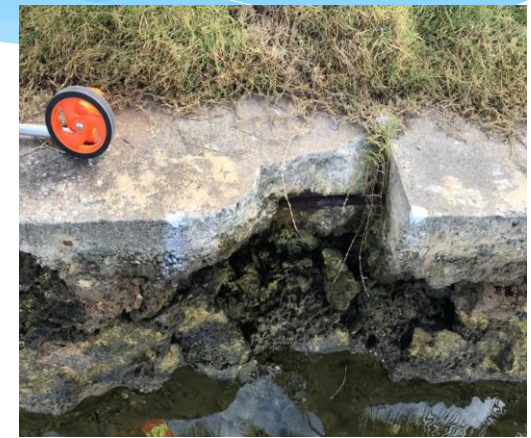
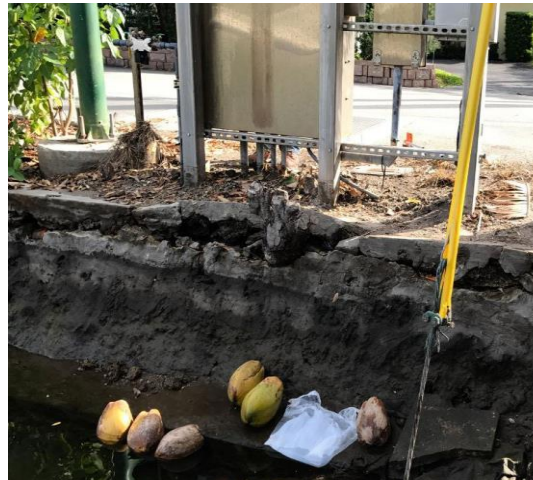
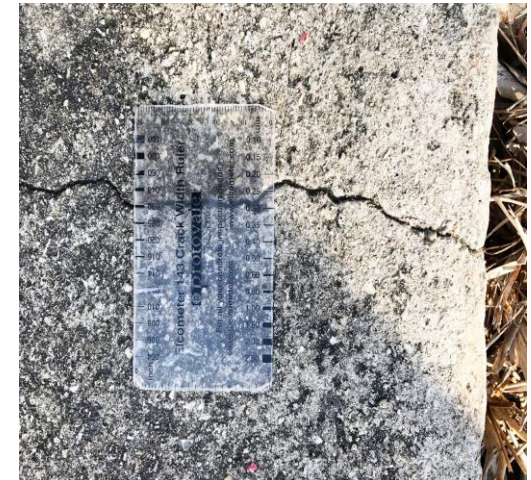
Existing Isle of Palms Seawall: Structural Condition

- **Constructed of:**
Coral rock seawall
- **Construction Date:**
Unknown
- **Average Cap Elevation:**
1.26' NAVD
- **Condition:**
Poor with significant horizontal and vertical displacement with loss of fill from behind the wall
- **2016 Seawall Assessment Masterplan Recommendation:**
Replacement and Raising within 0-5 years

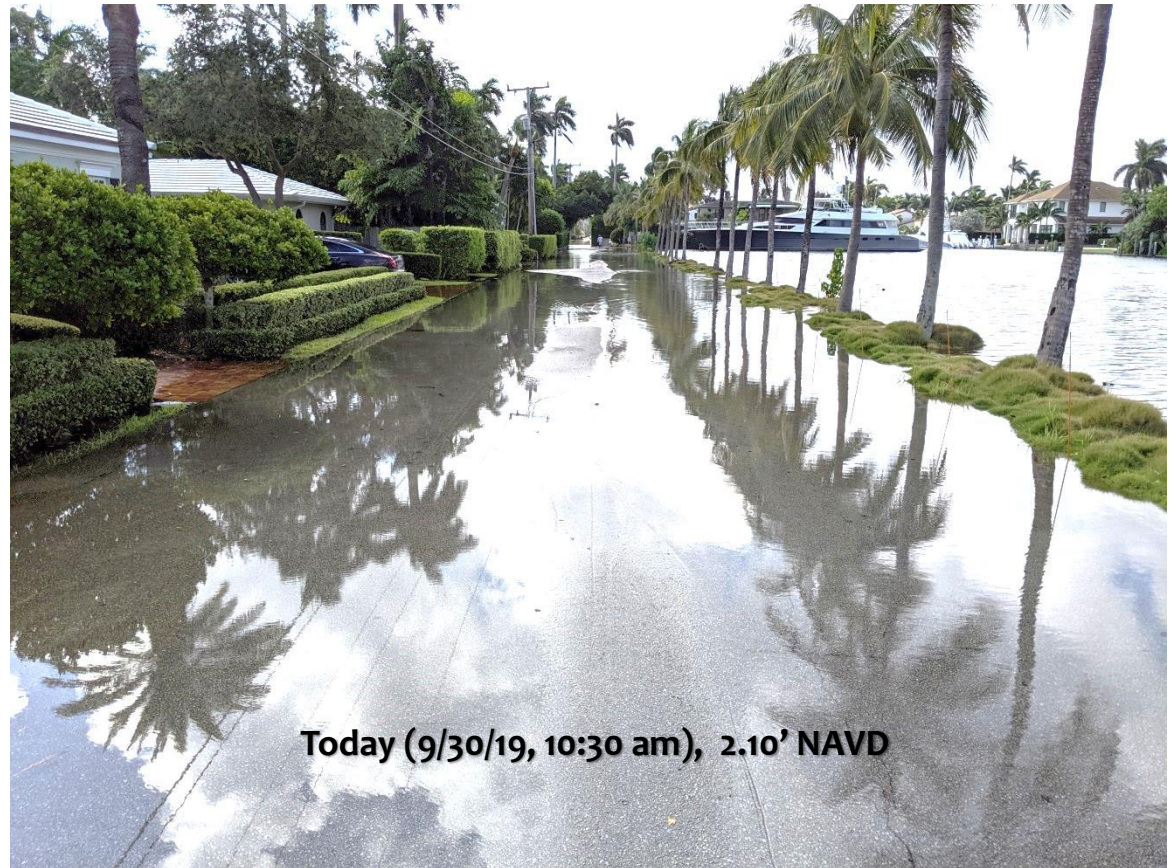
Isle of Palms Seawall: Current Top of Wall Elevation

- **Current Average Cap Elevation:**
1.26' NAVD
- Typical King Tide elevations range between 1.5' to 2.5' NAVD and are projected to increase.

Today (9/30/19, 10:30 am), 2.10' NAVD

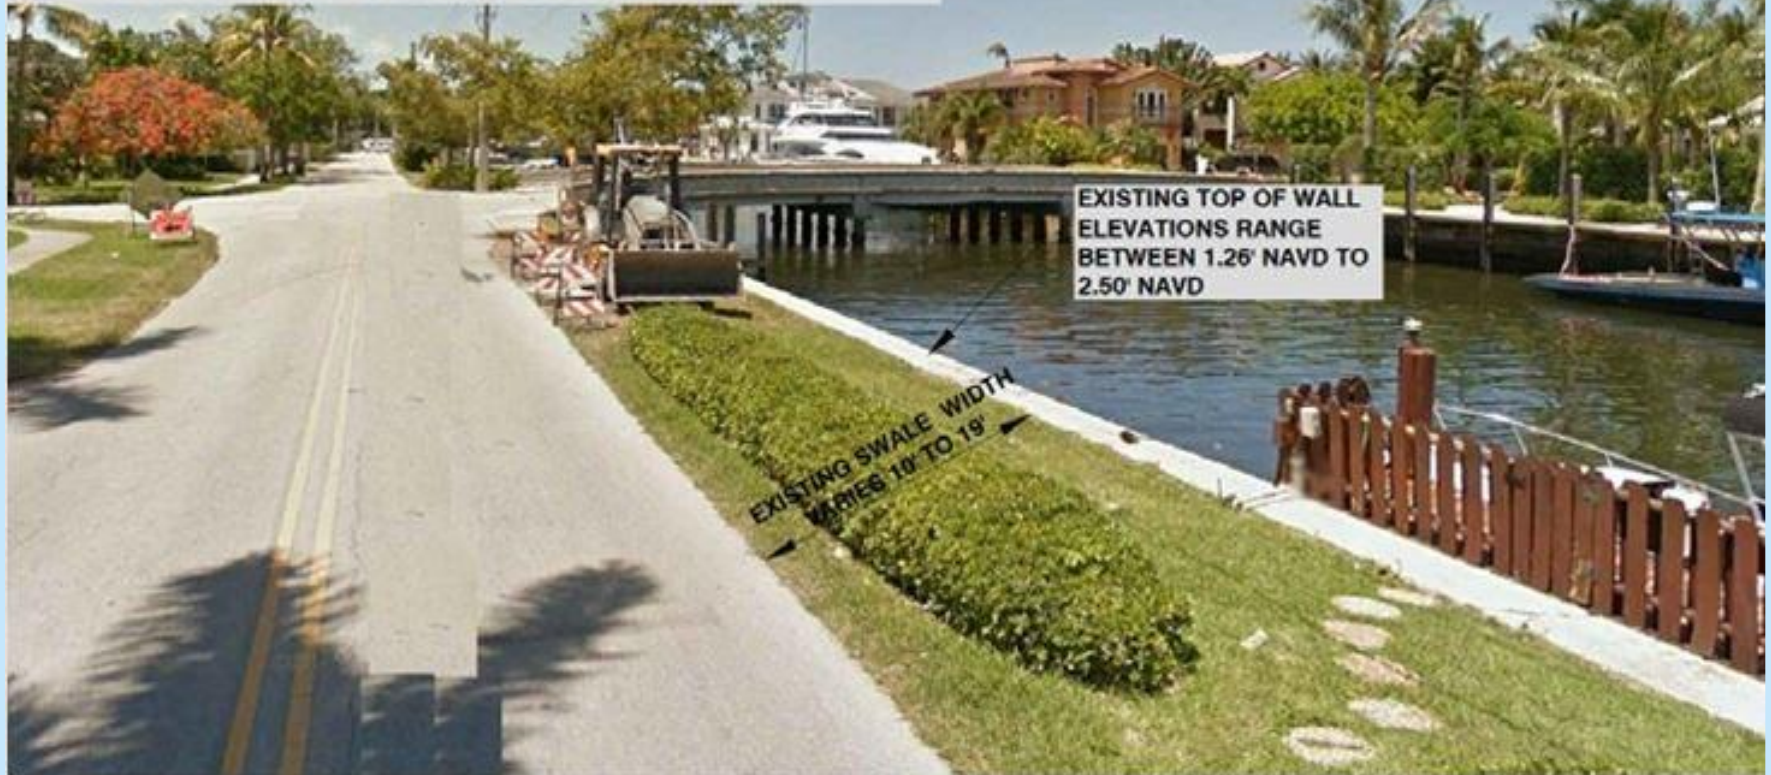
**PRE DEVELOPMENT TYPICAL CROSS-SECTION
CORDOVA ROAD LOOKING NORTH**

EXISTING TOP OF WALL
ELEVATIONS RANGE
BETWEEN 1.26' NAVD TO
2.50' NAVD

EXISTING SWALE WIDTH
VARIES 10' TO 19'
