**Memorandum No: 25-054**

**SUBJECT: New Police Headquarters — Phase 2 Peer Review**

**Draft Report**

April 22, 2025  
WJE No. 2024.4855.0

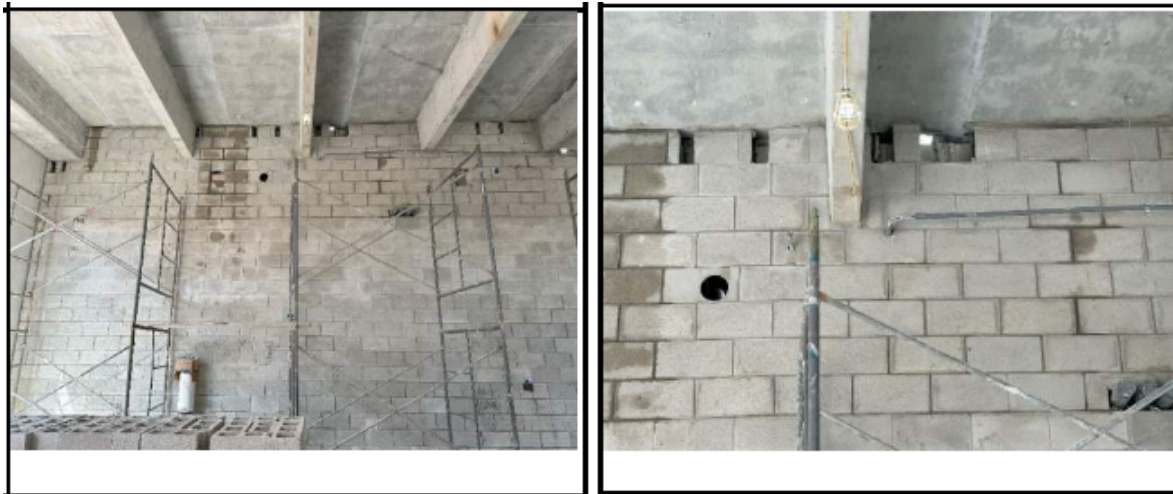
**Report No. 131, Dated March 19, 2024:** The TI notes that “Vertical reinforcement of Level 1 area D CMU checked for adequate lap splice.” Two photographs are shown of a wall that appears nearly complete (Figure 28).

Figure 28. Photographs from Threshold Inspection Report No. 131 showing a wall that is nearly complete

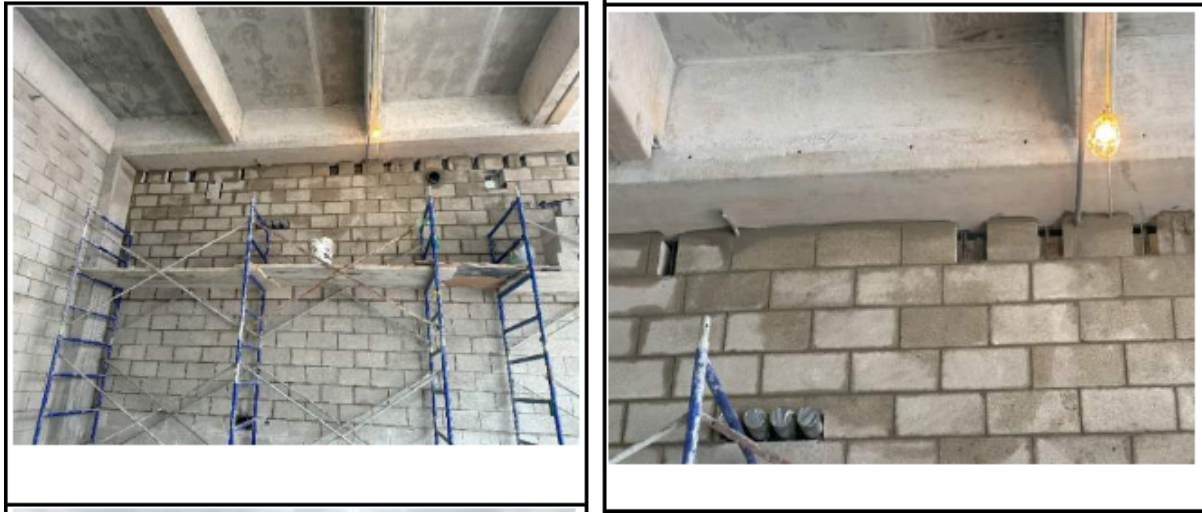
**Report No. 133, Dated March 21, 2024:** The TI notes that “Inspection of CMU on Level 1 area D between grid lines 15 and 16. Checked anchors are properly installed and rebar tied to them.” See Figure 29.

Figure 29. Photographs from Threshold Inspection Report No. 133 showing CMU wall at Level 1, Area D
