**SUBJECT: Police Headquarters WJE Clarification Letter – Phase 2 Peer Review Report – Life Safety Category**

**Draft Report**

April 22, 2025  
WJE No. 2024.4855.0

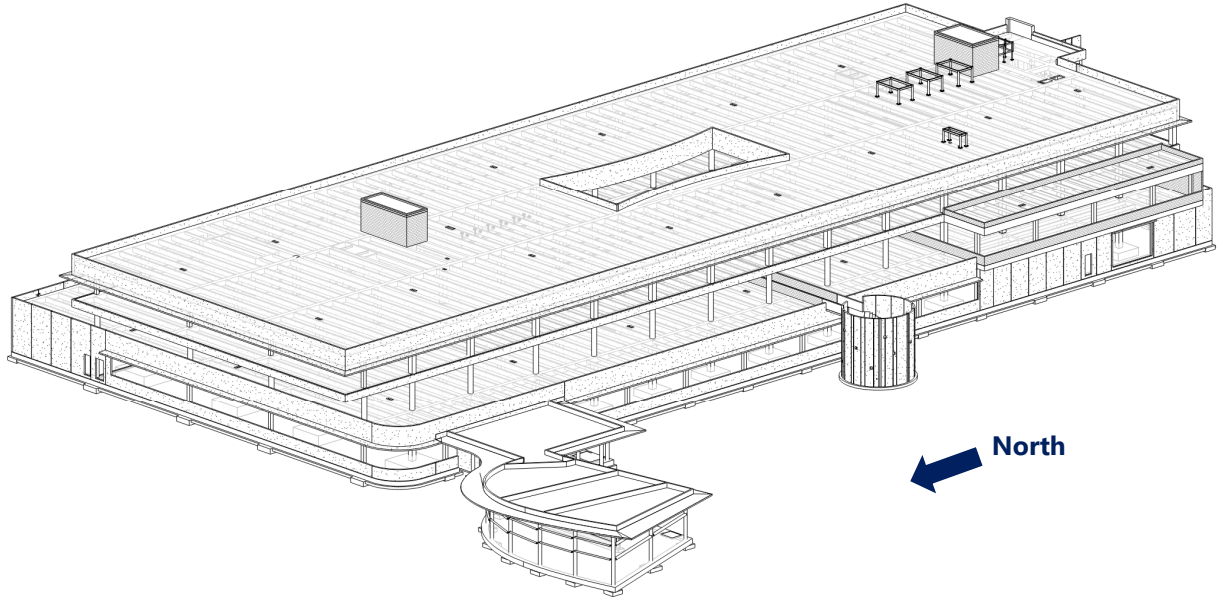
The main portion of the building is rectangular in plan, with the length of the building oriented on a north-south axis. The north elevation of the building has a step at the third floor and roof, forming a cantilevered projection at these floors. An isometric view of the building is shown in Figure 1. The facade of the building is clad with a combination of precast concrete fascia and full-height glass fenestration systems. An overall plan view of the foundation level of the building and the gridlines is shown in Figure 2.

Figure 1. Isometric view of the Fort Lauderdale Police Headquarters building from Sheet HQ-S0-1-00 (dated June 10, 2022) of the structural design drawings. Annotations in blue by WJE

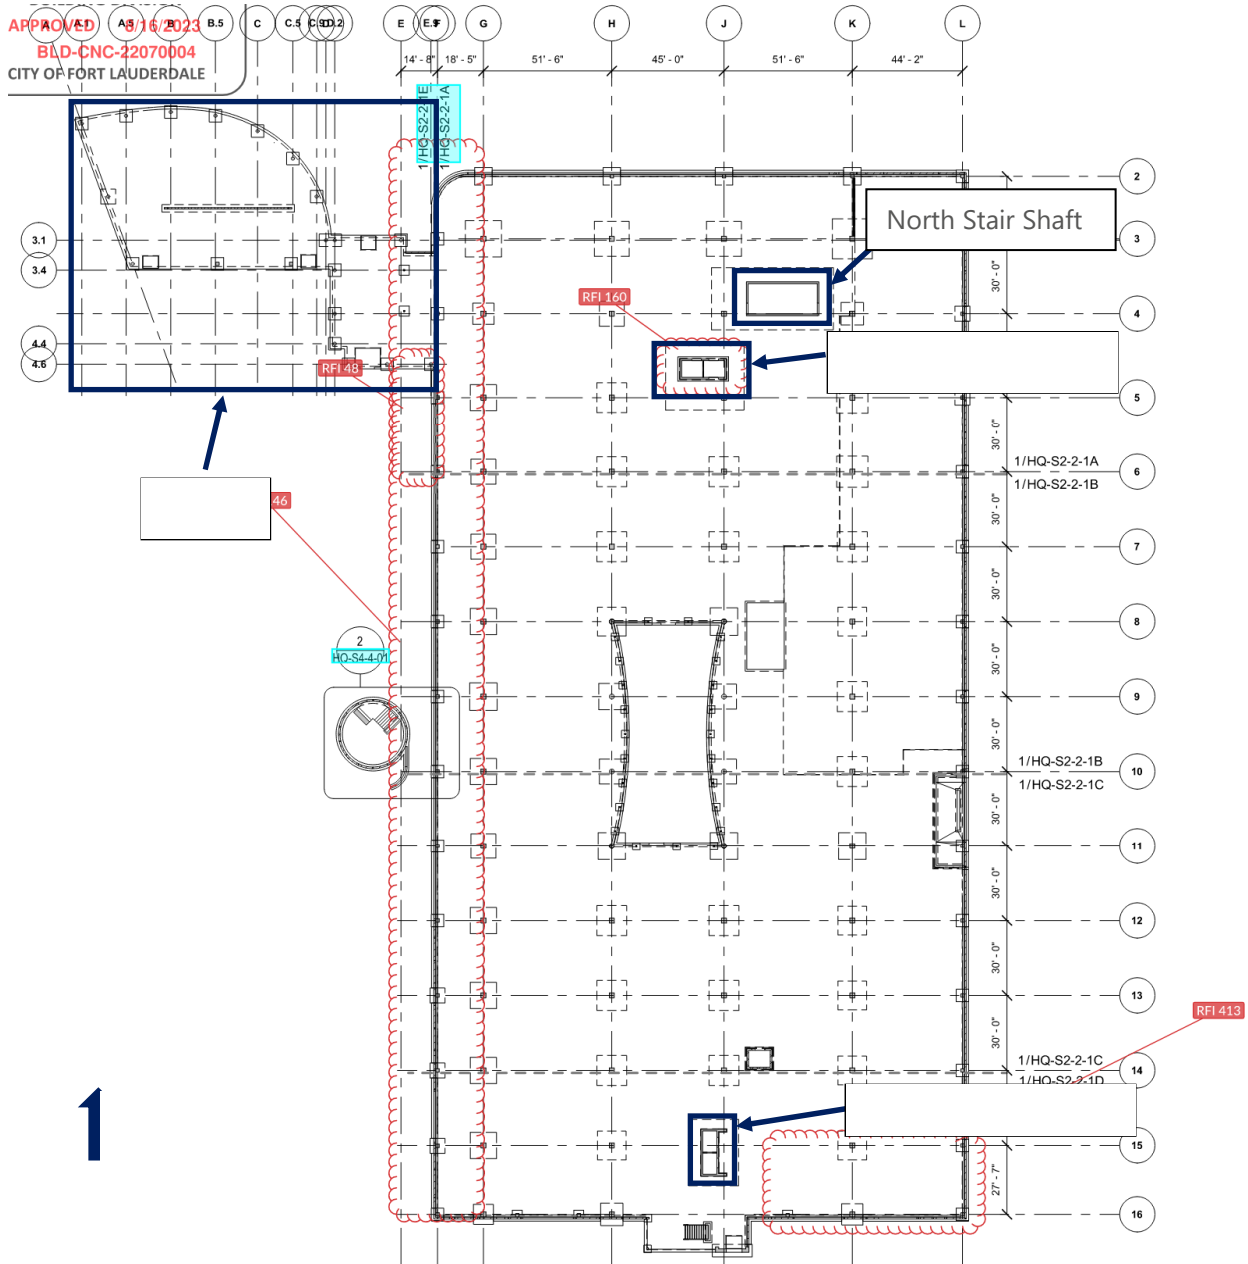
Figure 2. Plan view of the foundation level of the FLPHQ from Sheet HQ-S2-2-01 (dated June 10, 2022) of the structural design drawings with gridlines and shear wall locations shown. Annotations in blue by WJE

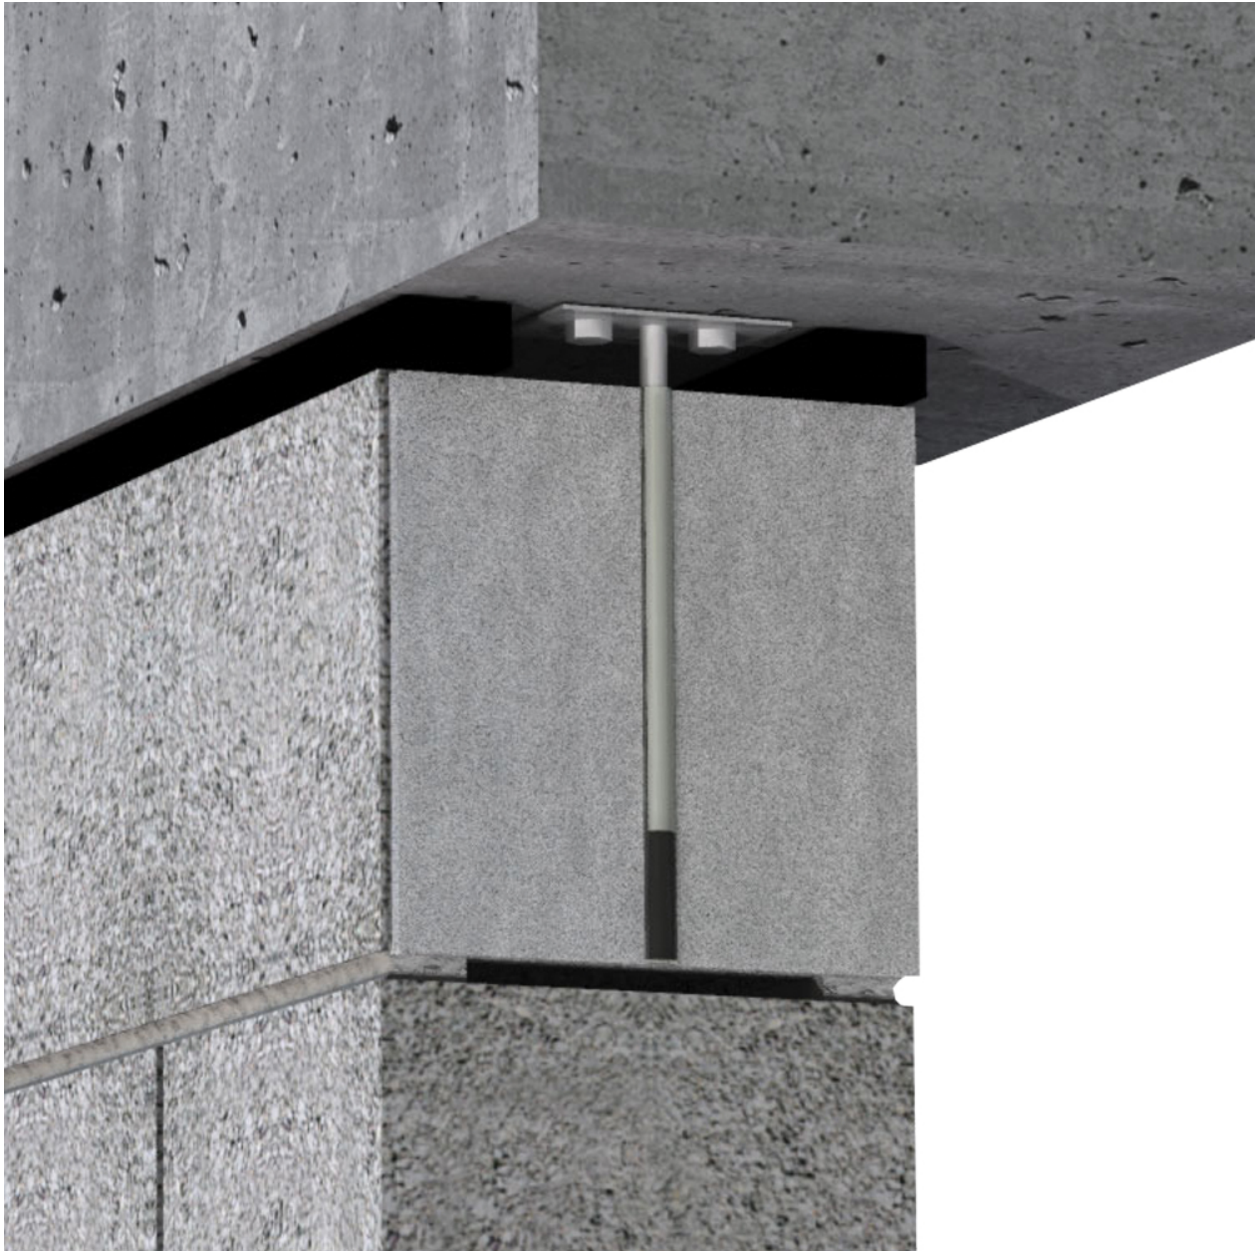
Figure 10. Rendering of installed PTA 420 HS anchor from Hohmann and Barnard. Image taken from <https://www.h-b.com/products/pta-series-anchors-pta-420-hs> (accessed on April 13, 2025). Note that the length of the top plate of the anchor is oriented transverse to the length of the wall

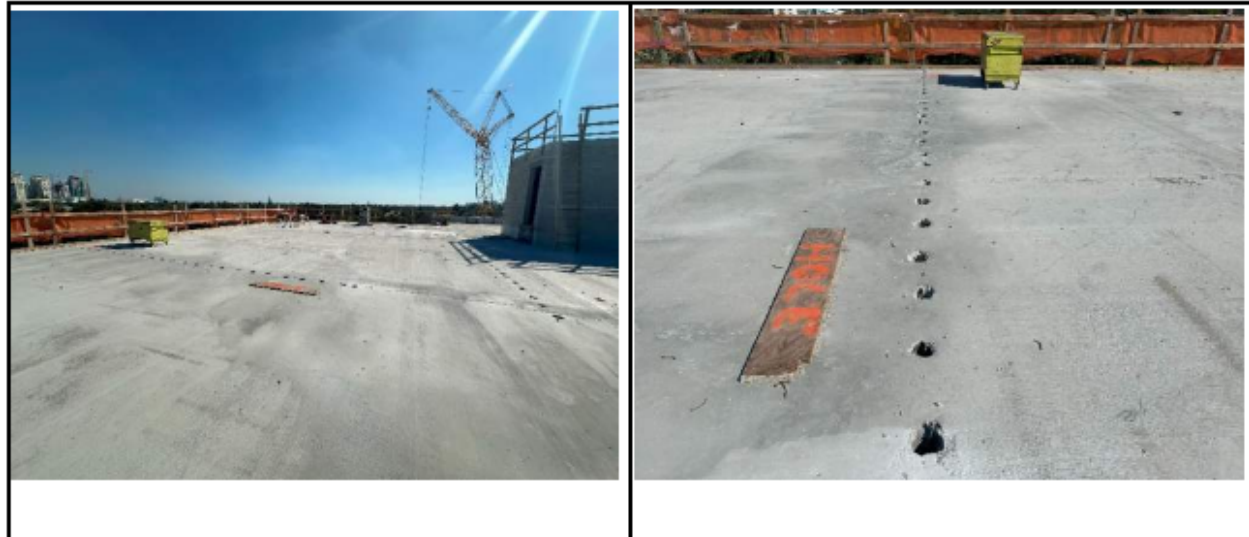
**Report No. 101, Dated January 31, 2024:** The TI notes that “Checked vertical reinforcement of Level 3 area C CMU wall and there were two bars that were not tied to the coming dowels from previous block pour.” Photographs were included that appear to be of the third floor slab (Figure 21), but no photographs were included for the referenced condition.

Figure 21. Photographs from Threshold Inspection Report No. 101. While not clearly stated in the report, these images are believed to be of the third floor slab

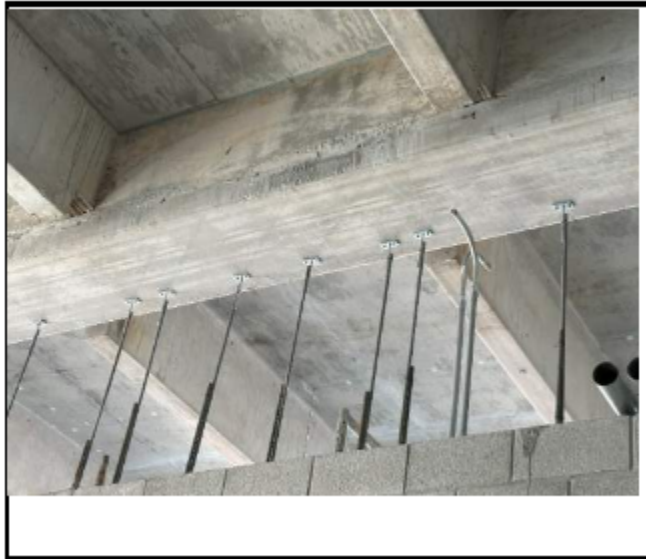
**Report No. 125, Dated November 27, 2023 (Note that Report No. 124 is dated March 6, 2024 and Report No. 126 is dated March 12, 2024):** The TI notes that “Confirmed that vertical reinforcement anchors are being tied as per specification using two tapcon screws instead of one.” This statement appears to refer to the TI's comment in Report No. 123 above. A photograph of this condition was provided (Figure 27).

Figure 27. Photograph from Threshold Inspection Report No. 125 showing PTA connectors at bottom of soffit beam with the two screws attaching the plate of the anchor to the soffit beam

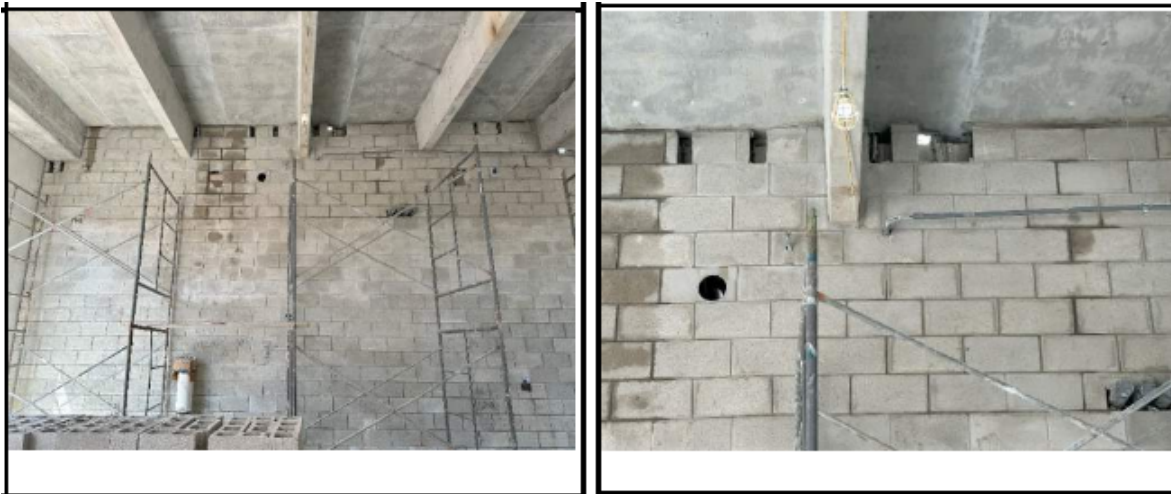
**Report No. 131, Dated March 19, 2024:** The TI notes that “Vertical reinforcement of Level 1 area D CMU checked for adequate lap splice.” Two photographs are shown of a wall that appears nearly complete (Figure 28).

Figure 28. Photographs from Threshold Inspection Report No. 131 showing a wall that is nearly complete
